Damage Assessment Criteria for the Classification of Light Vehicle Statutory Write-Offs

National Motor Vehicle
Theft Reduction
Council

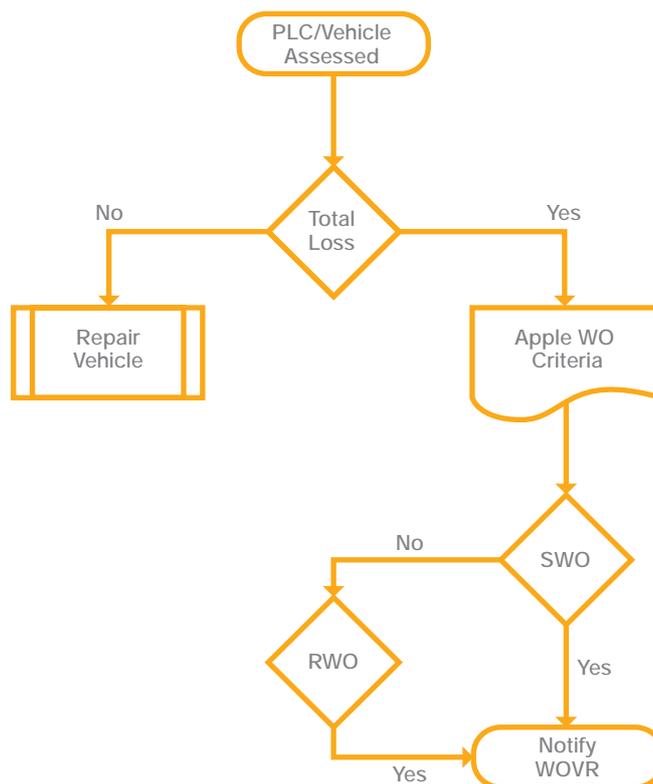
This guide is intended to be used by insurance personnel and other *notifiers* who are required to classify WOVs for regulatory purposes. It has been prepared on the basis that it provides sufficient technical precision to be able to be expressly referenced as an incorporated instrument under State and Territory law should a jurisdiction wish to do so. See Figure 1 for an overview of the end to end *assessment* process.

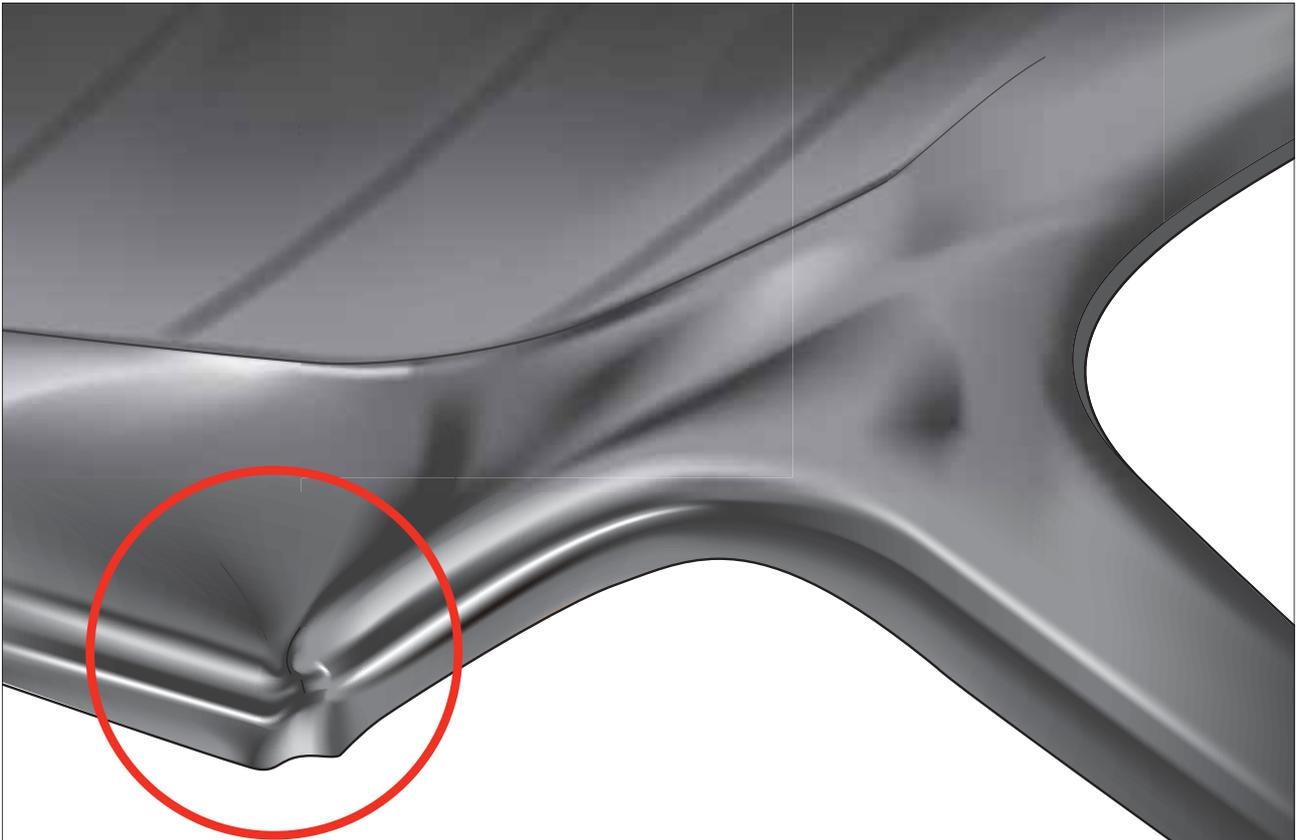
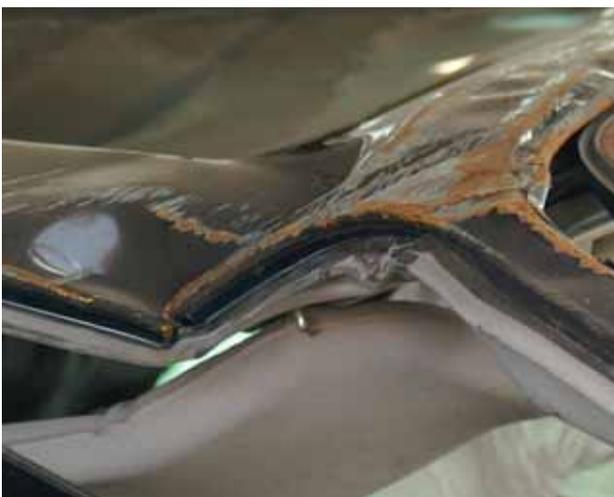
1.1 Roof – buckled

View of the roof, windscreen header, front left door header and 'A' pillar. The roof has been structurally loaded such that the windscreen header has buckled.

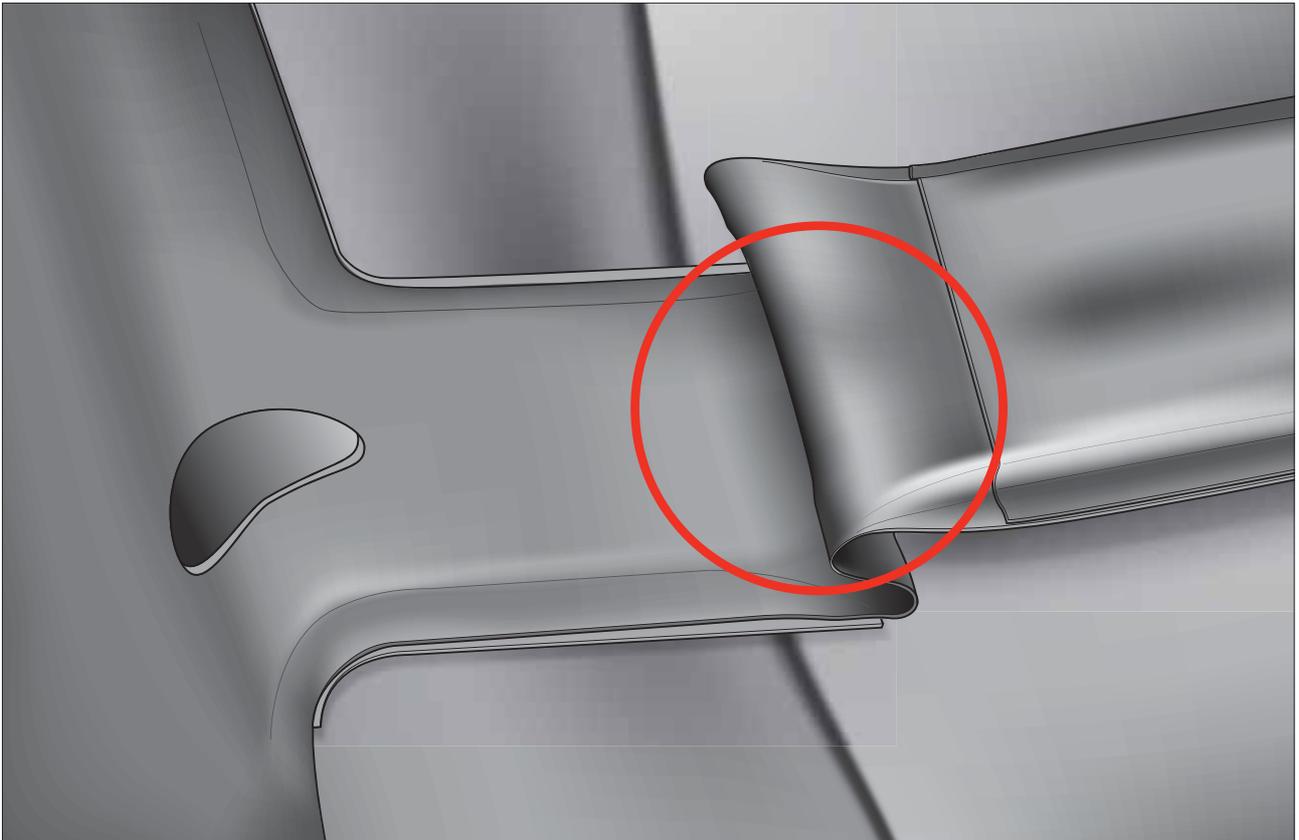
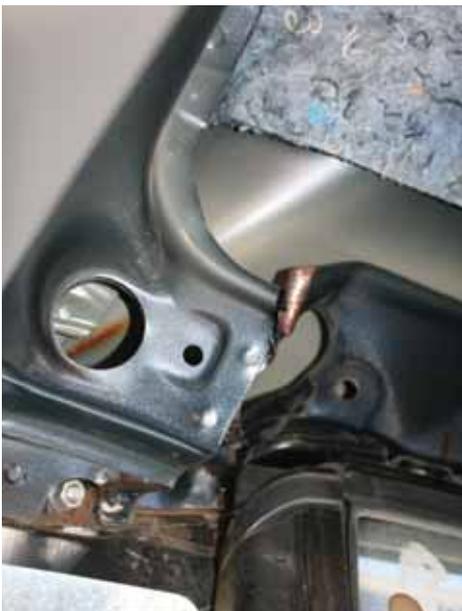
1.2 Roof support rail – folded

Internal view of lateral roof rail which due to structural loading has folded over onto itself.

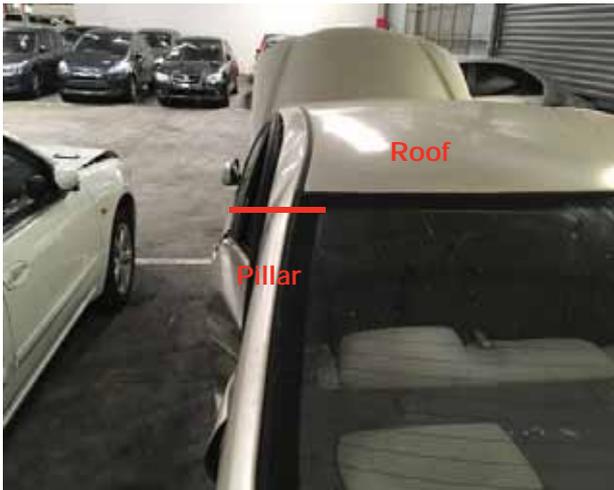
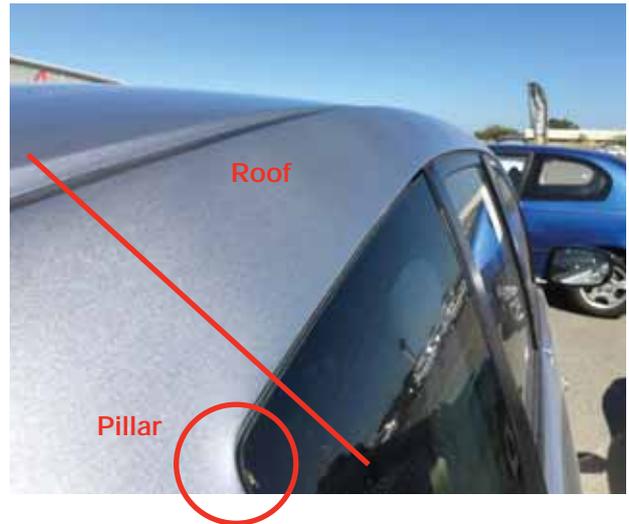
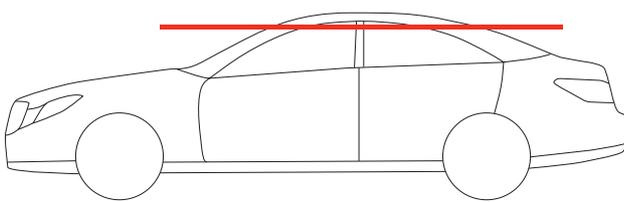
Roof v Delineation

It is therefore recommended that Assessors apply a virtual halo to the side elevation of a subject vehicle, with those parts of the structure within the halo to be classified as forming part of the roof.

Above the horizontal line equals roof.

A 2017 audit of assessed total losses found a small number of cases where load damage reaching into the roof area was assessed to be contained to the adjoining pillar only. The problem is exacerbated in vehicles featuring sweeping, complex roof lines.

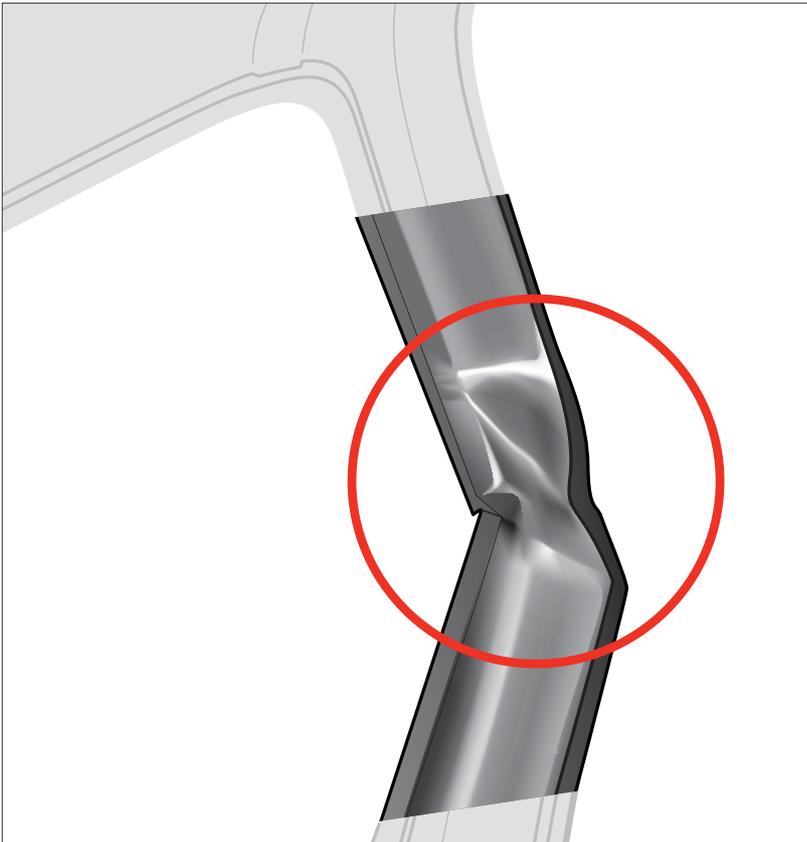
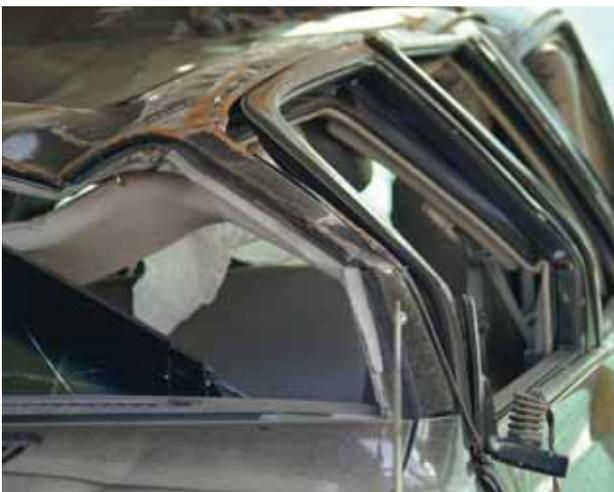
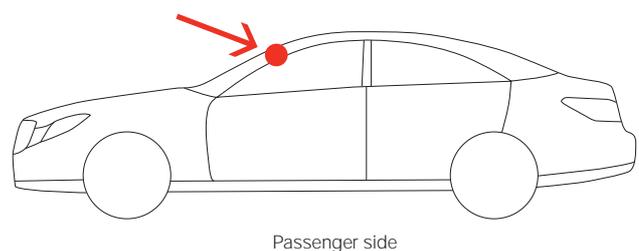
2.1 'A' pillar – buckled

A vehicle 'A' pillar which has failed by buckling due to structural loads to the roof.

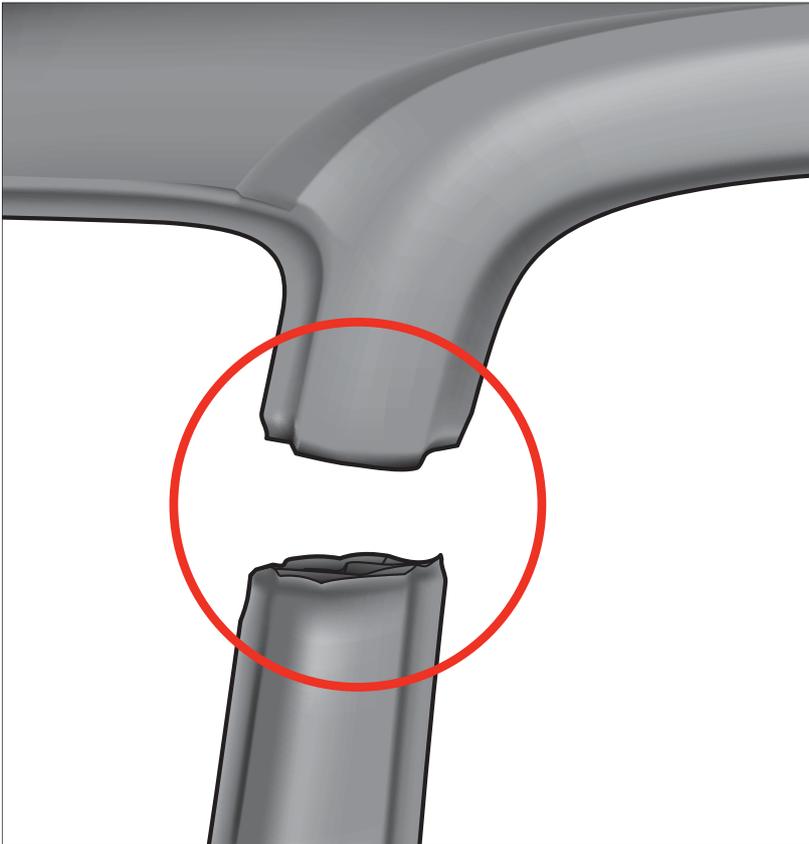
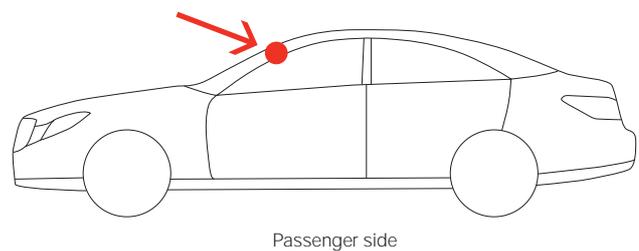
2.2 'A' pillar – cut

The 'A' pillar of a vehicle which has been cut (e.g. by emergency services personnel to permit occupant extraction).

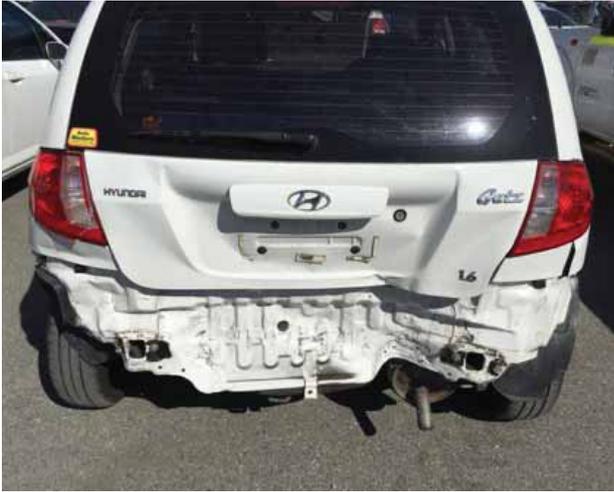
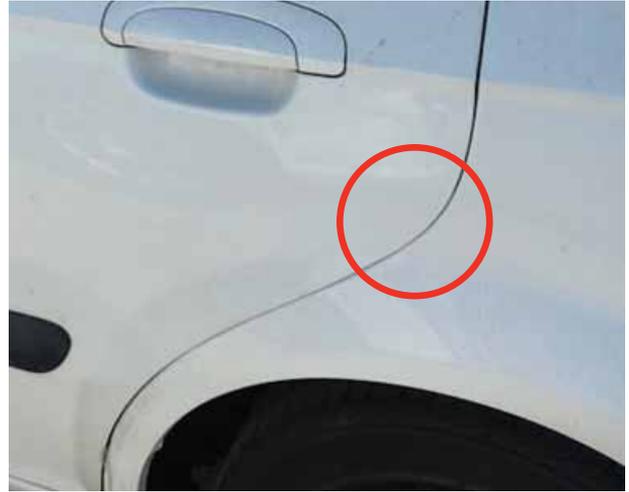
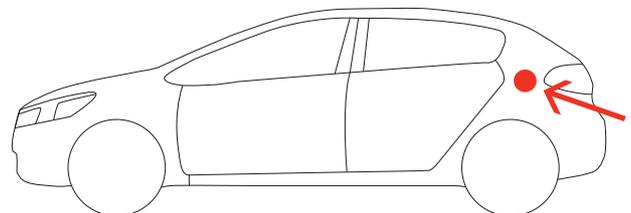
Small car – Rear offset impact resulting in closed rear door aperture

In small cars, closed rear door apertures should be regarded as symptomatic evidence of an underlying structural indicator being present but not readily visible or accessible.⁴

This is most likely to occur only in the smallest passenger vehicles involved in an off-set rear impact resulting in hidden damage to the rear longitudinal rail and pillar.

4. A 2017 audit of assessed total losses found several examples of body misalignment indicating a structural load in the rear pillars (evidenced by the closure of rear door gaps) without a visible load indicator eg. buckle, crack, cut, fold or fracture. In practice, this approach is already applied routinely in respect of many frontal impacts where it is obvious from adjoining damage that a structural load must have been transferred to, say, the vehicle's firewall but the physical evidence is hidden by contiguous damage or is inaccessible. In field audits, the problem was not evident in small-medium or larger vehicles.

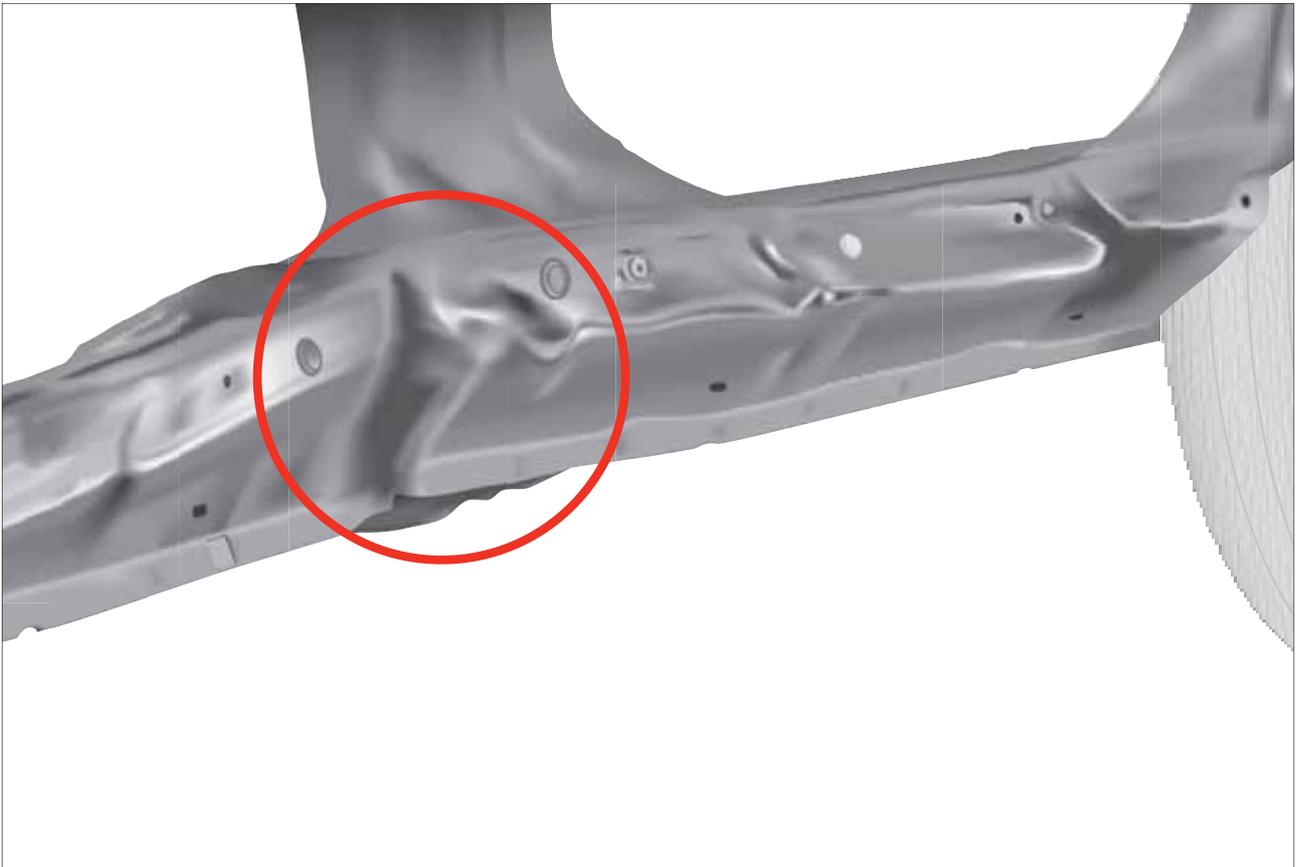
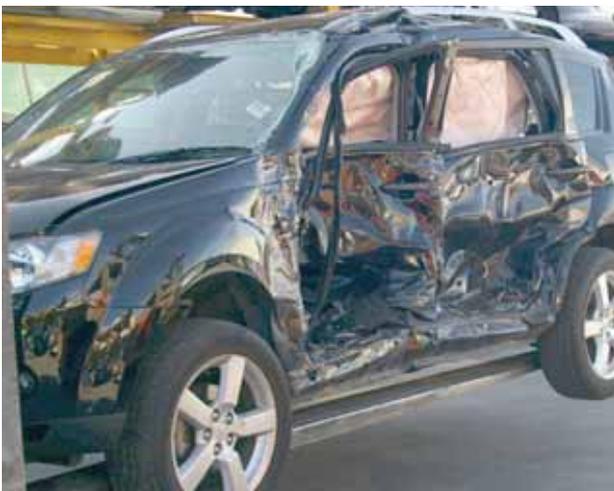
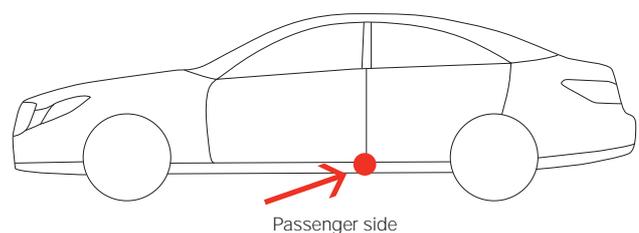
3.1 Floor pan – buckled

A side view of a vehicle showing buckling and folding of the floor.

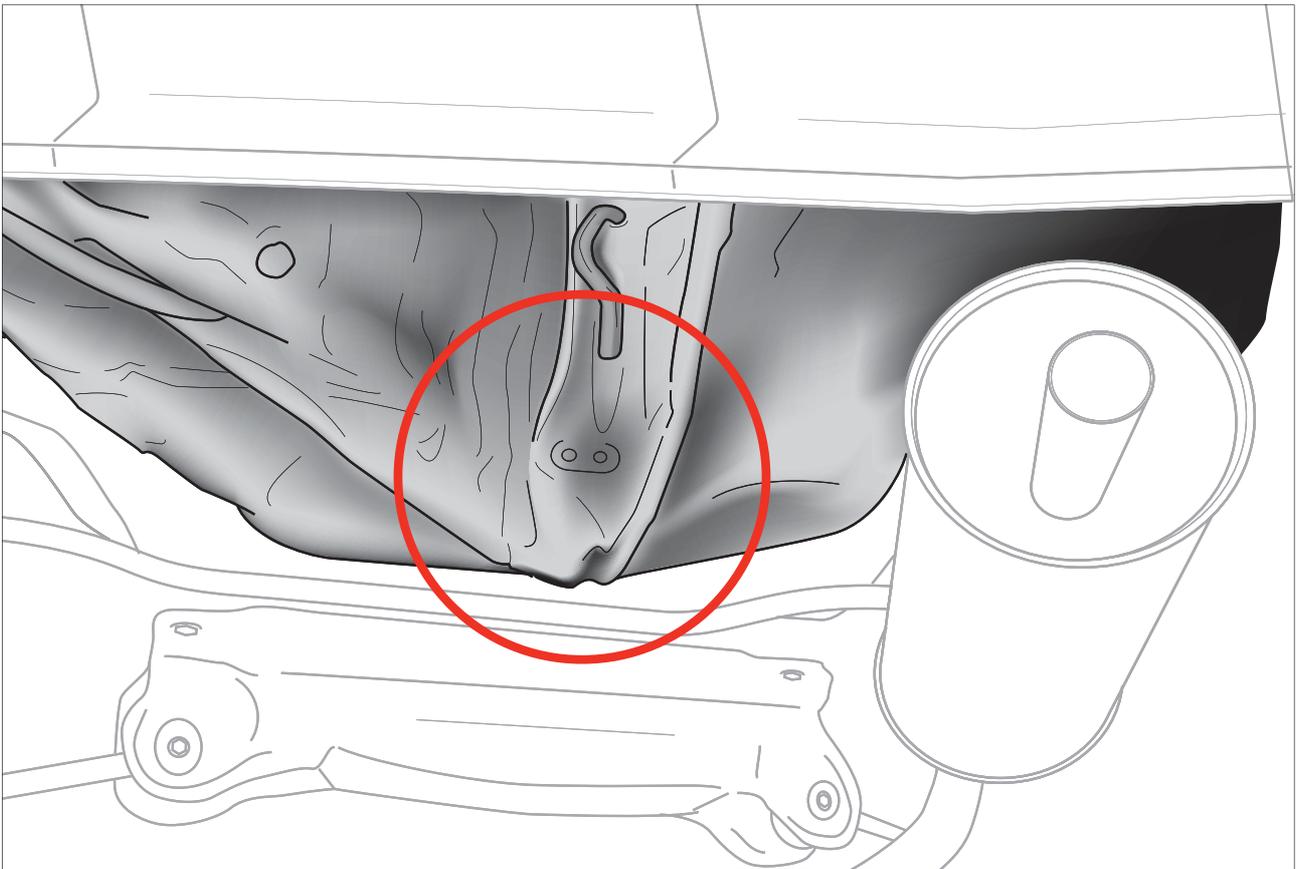
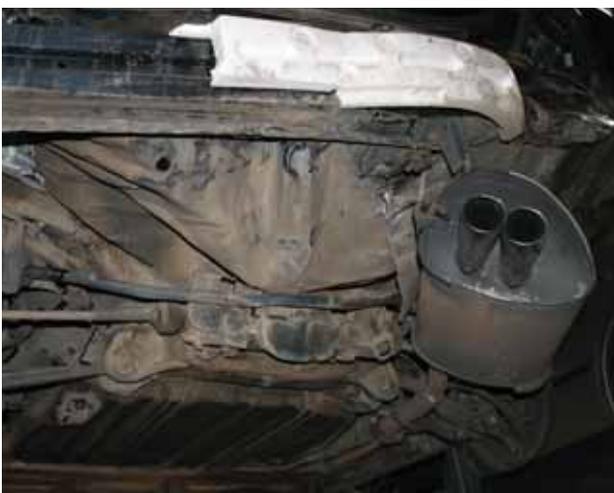
3.2 Floor pan – buckled

View of the rear underneath of a vehicle showing buckling of the floor pan.

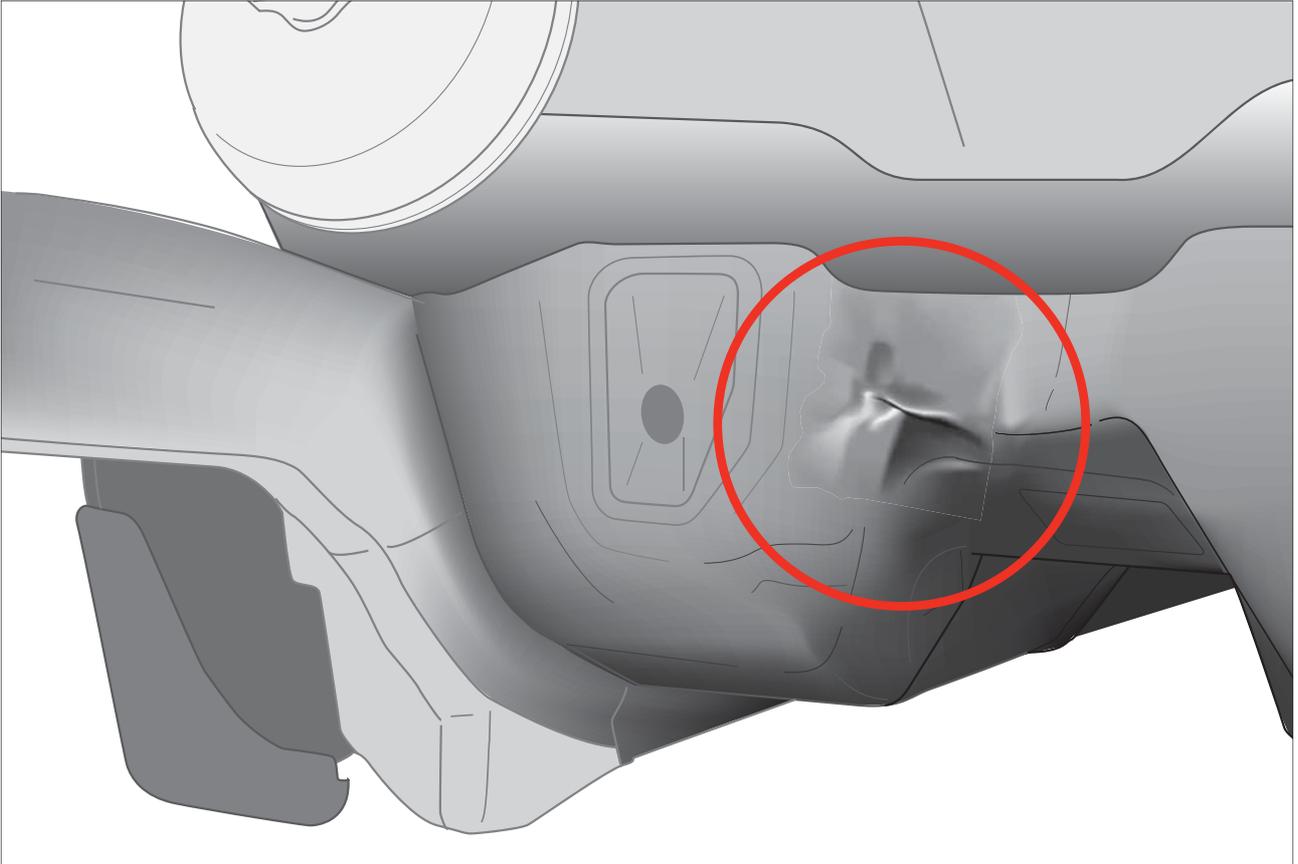
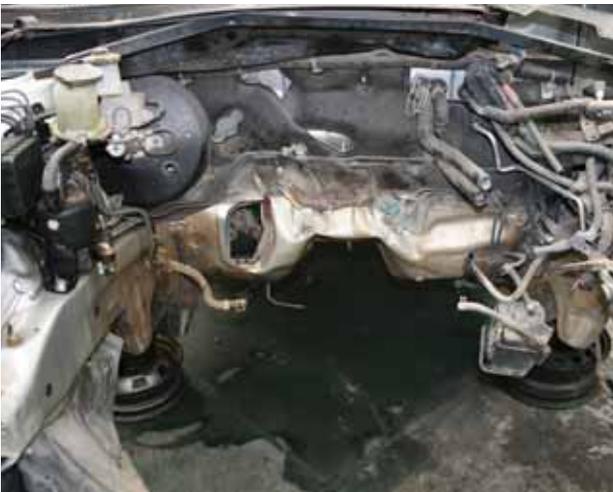
4.1 Firewall – folded

View of the firewall showing a fold induced by impact damage.

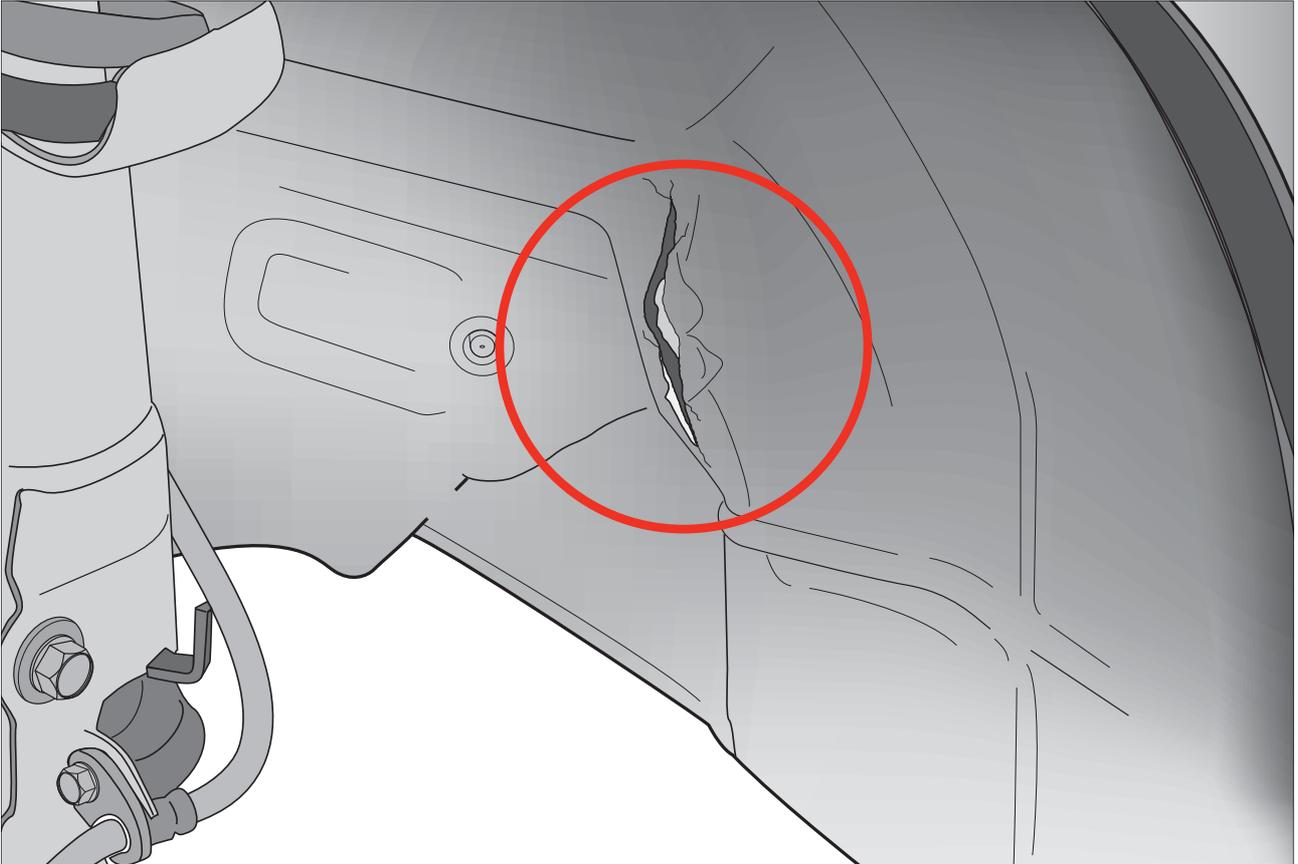
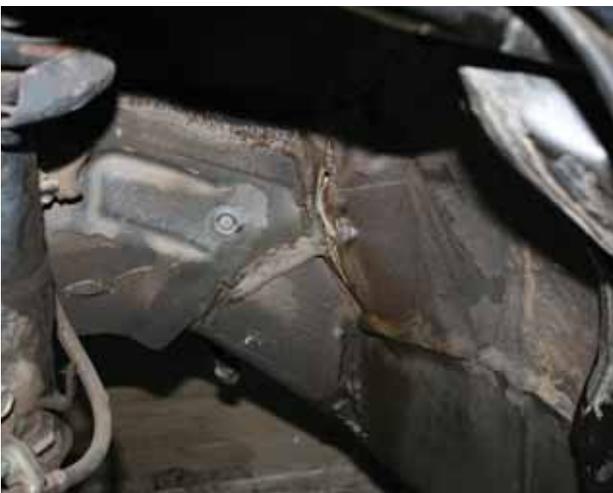
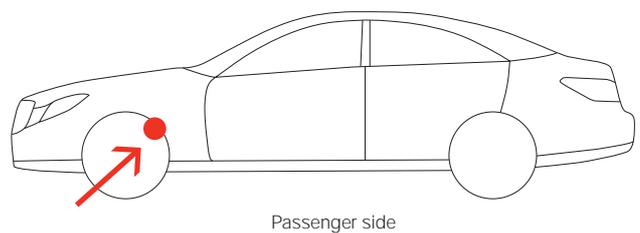
4.2 Firewall – cracked

View through the front left wheel-well of the firewall showing a crack in the firewall.

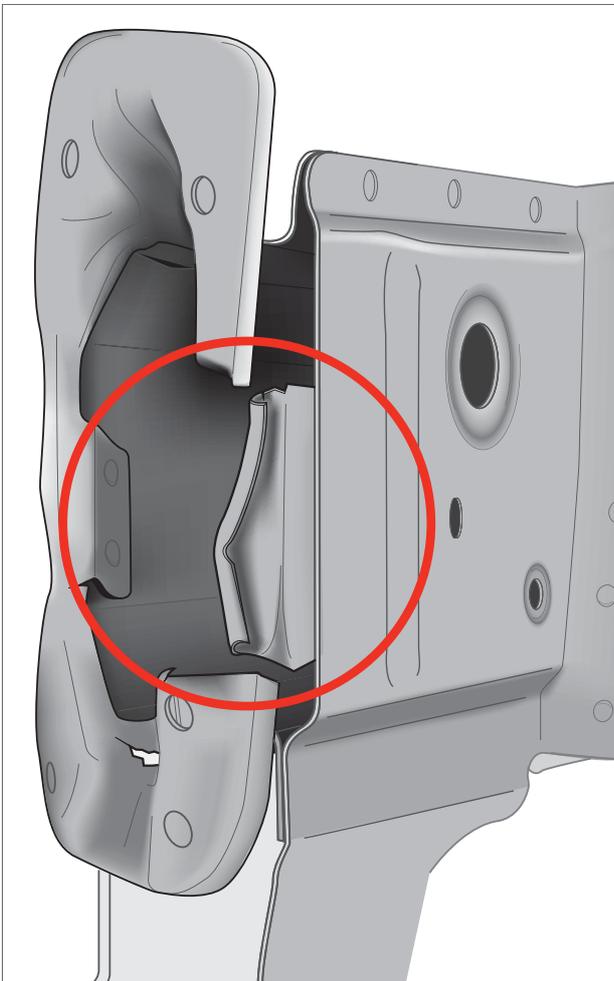
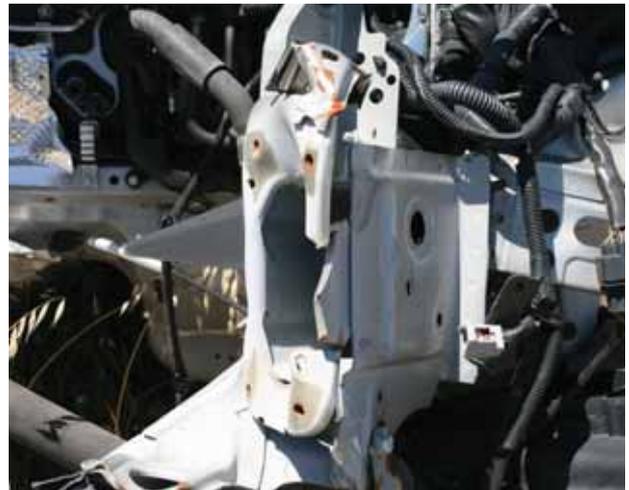
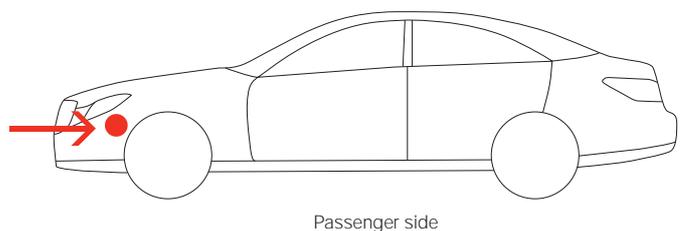
5.1 Chassis rail – fractured

View of longitudinal structural rail/chassis fractured due to impact.

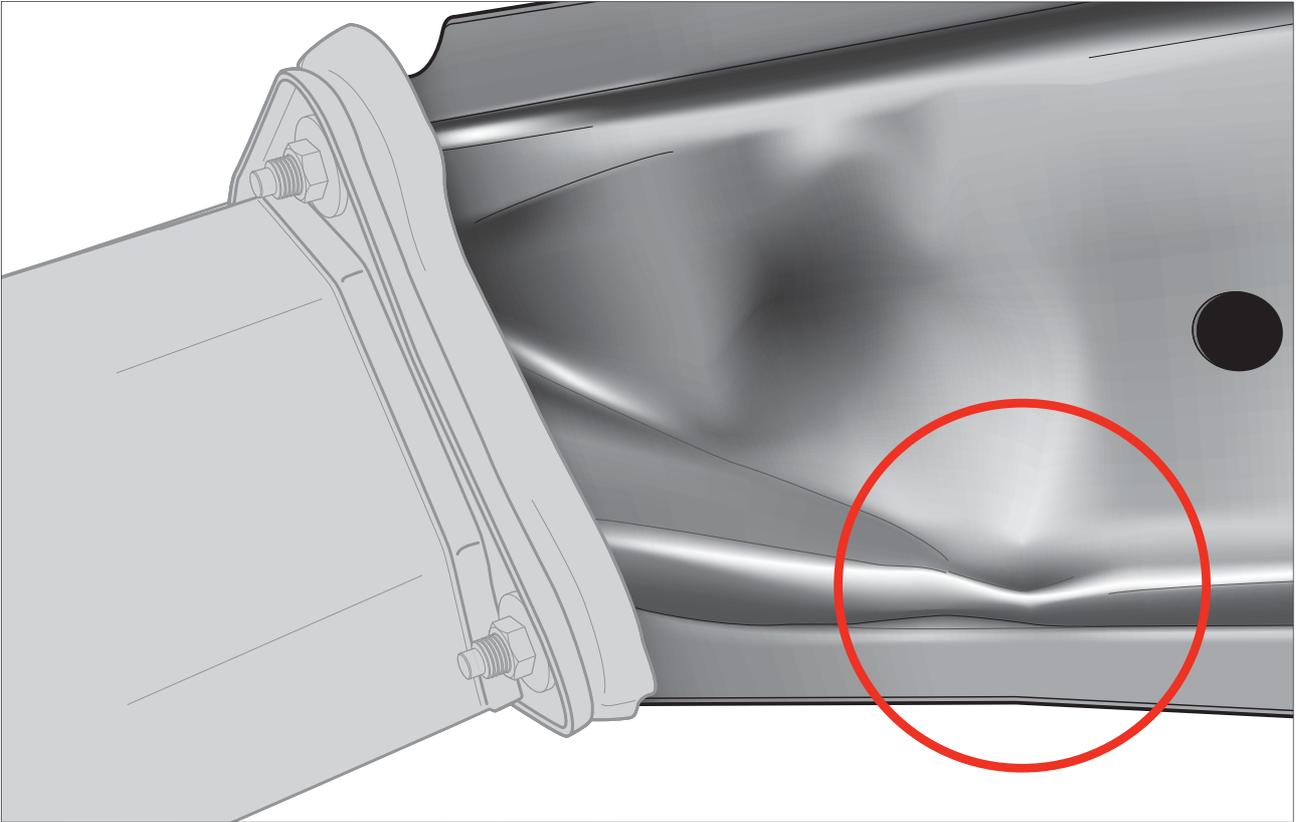
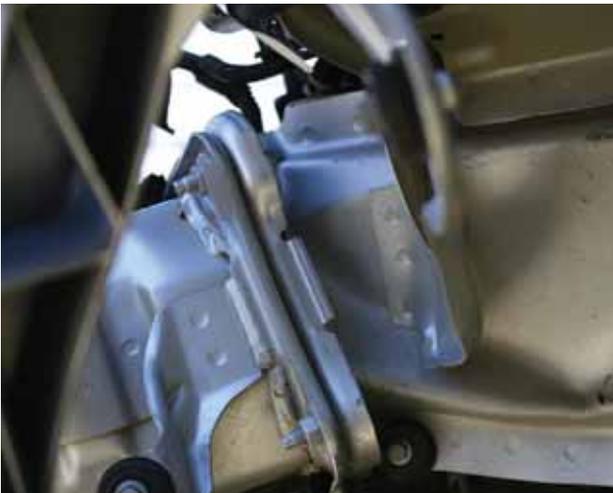
5.2 Chassis rail – buckled (side view)

View of a longitudinal structural/chassis rail which has buckled due to structural impact loading.

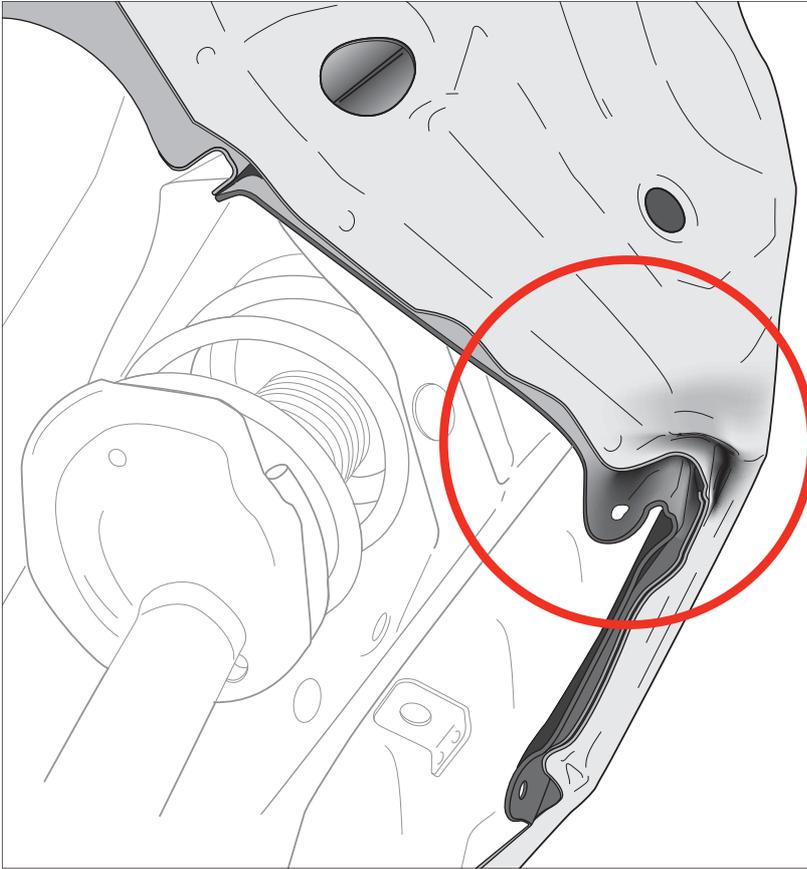
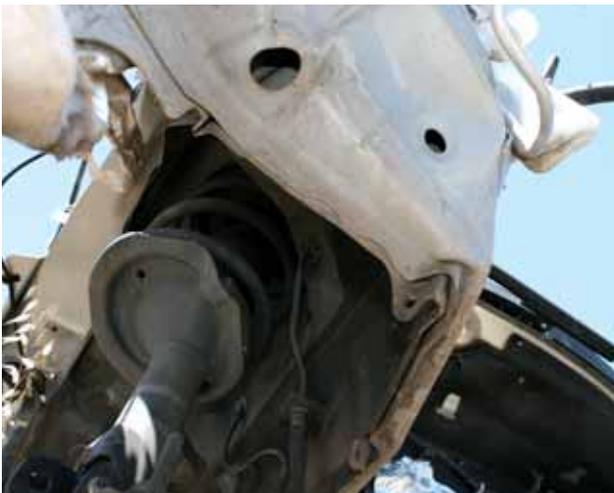
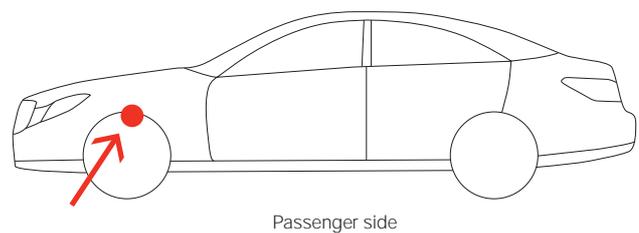
5.3 Chassis rail – folded

View of a longitudinal structural/chassis rail which has folded due to a side impact.

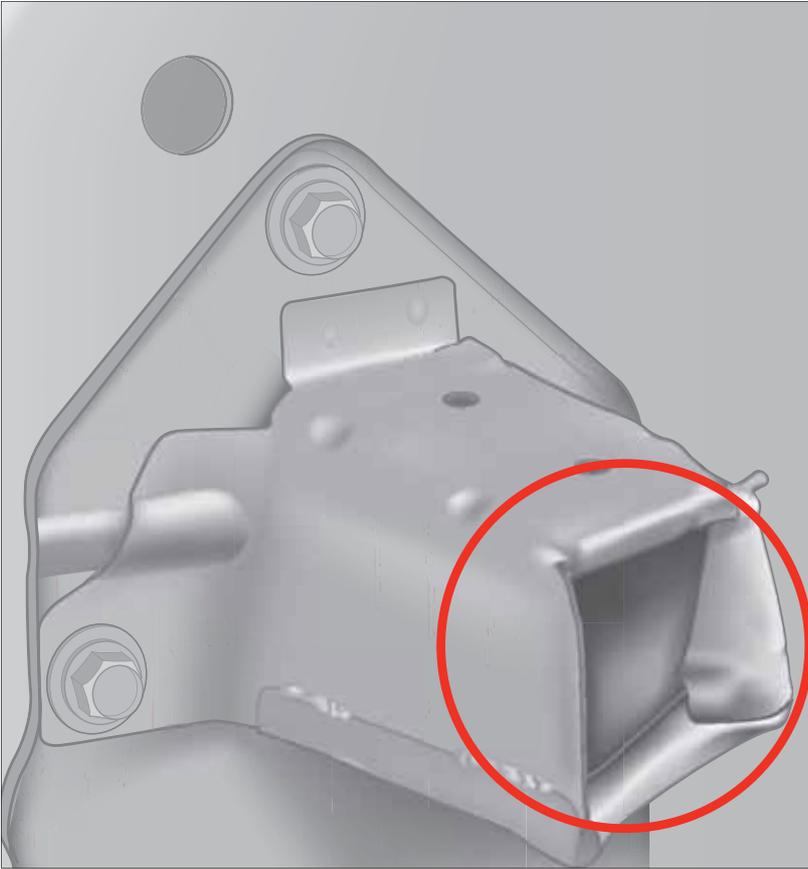
5.4 Deformable crush tube – damaged

This is an example of a deformable end plate that is designed to be removed and replaced. Such components are not to be registered as a damage count.

Note: A deformable member that is designed to be removed and replaced is not considered a fundamental structure of the vehicle if damaged and such components are not to be registered as a damage count.

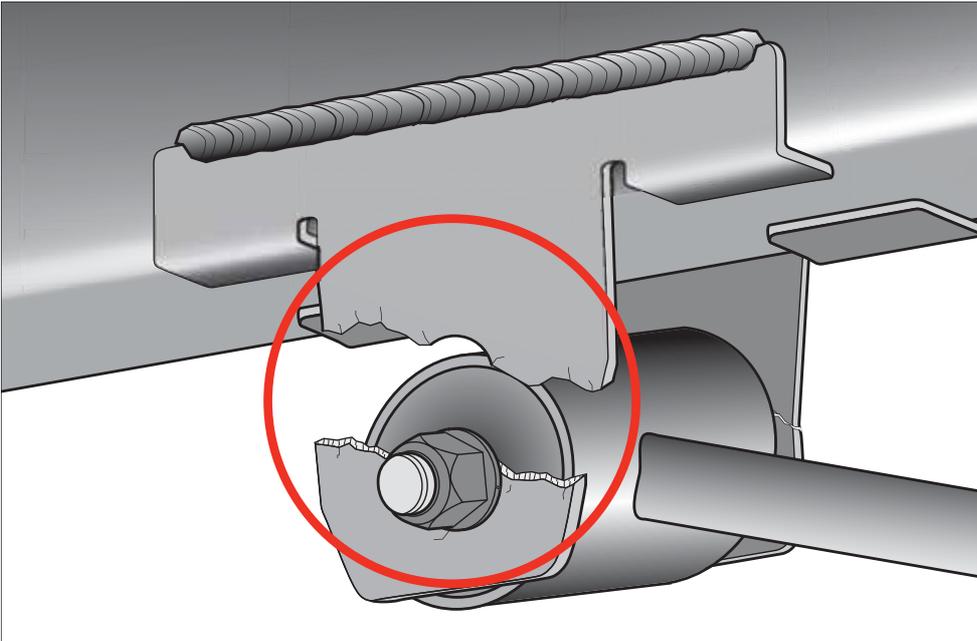
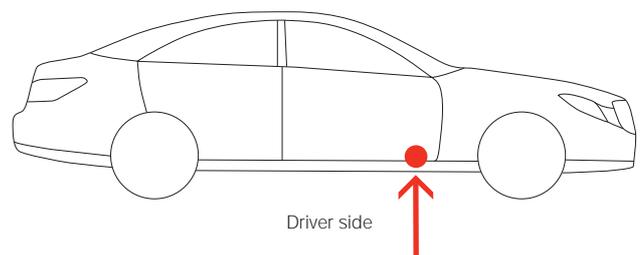
6.1 Suspension mount – fractured

View of a fractured suspension mount.

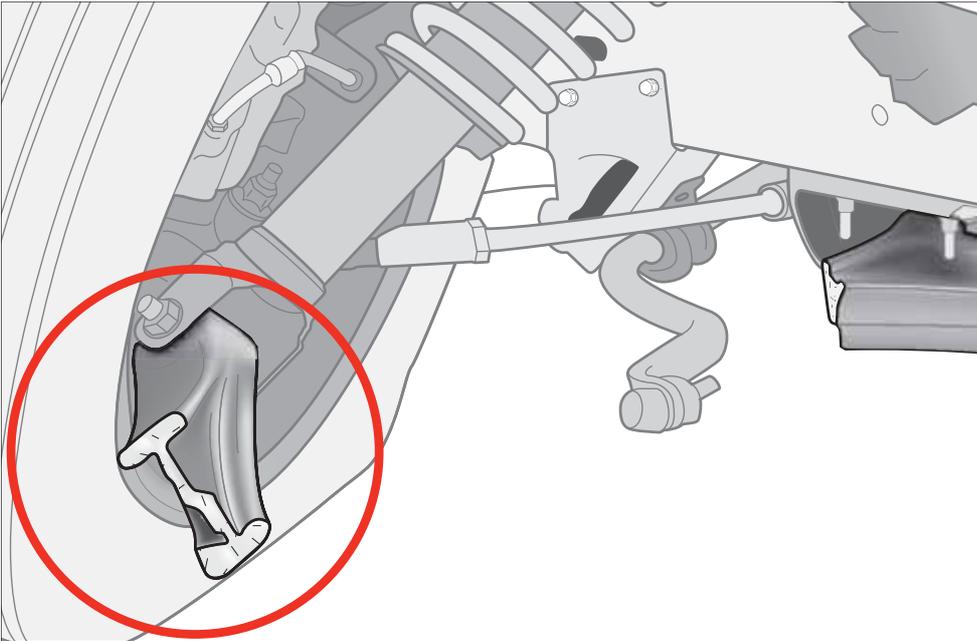
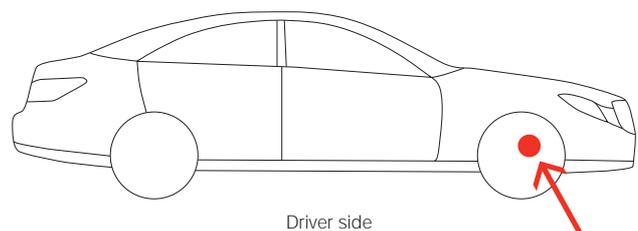
6.2 Suspension and linkages – damaged

This is an example of damaged suspension components that do not form part of the damage criteria because components such as suspension arms and linkages are designed to be removed and replaced.

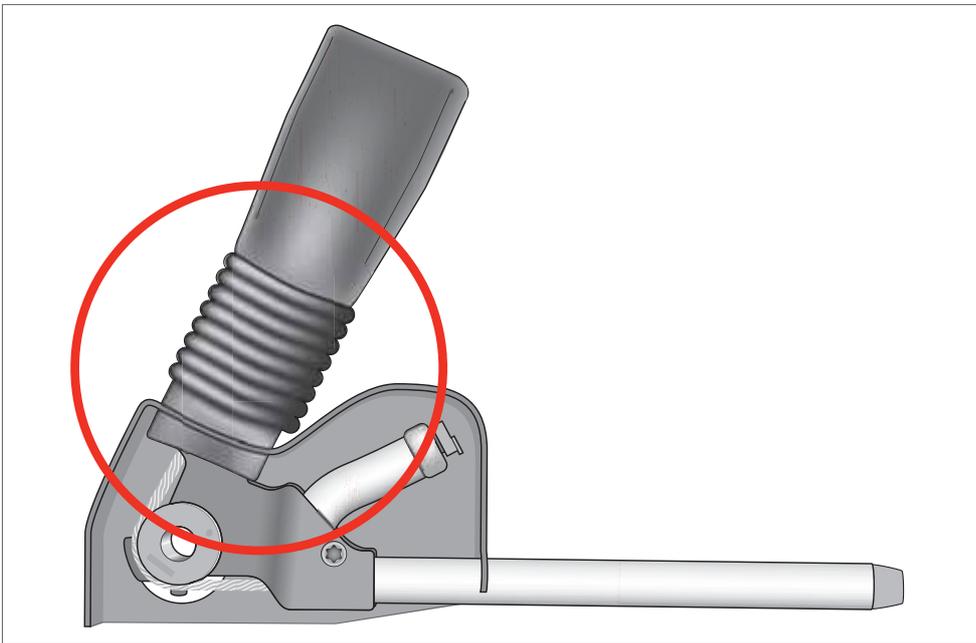
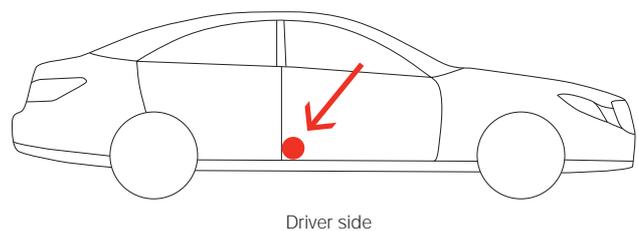
7.1 Pre-tensioner – active

View of a seat belt buckle showing a buckle with an active pre-tensioner.

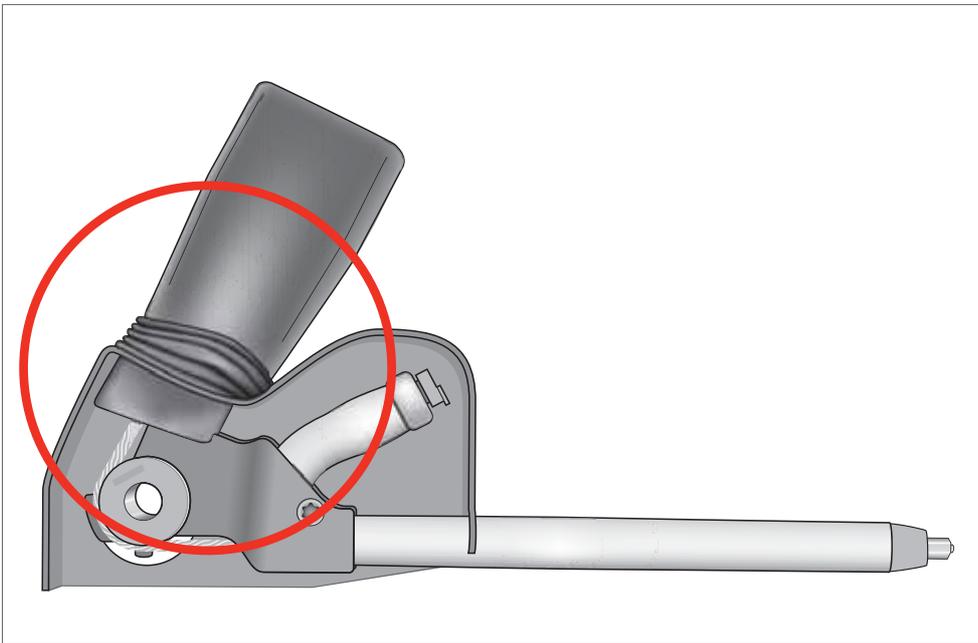
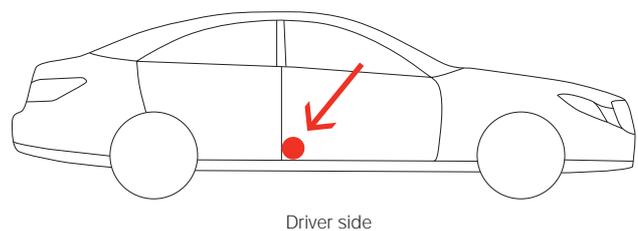
7.2 Pre-tensioner – fired

View of a seat belt buckle showing a buckle with a used pre-tensioner.

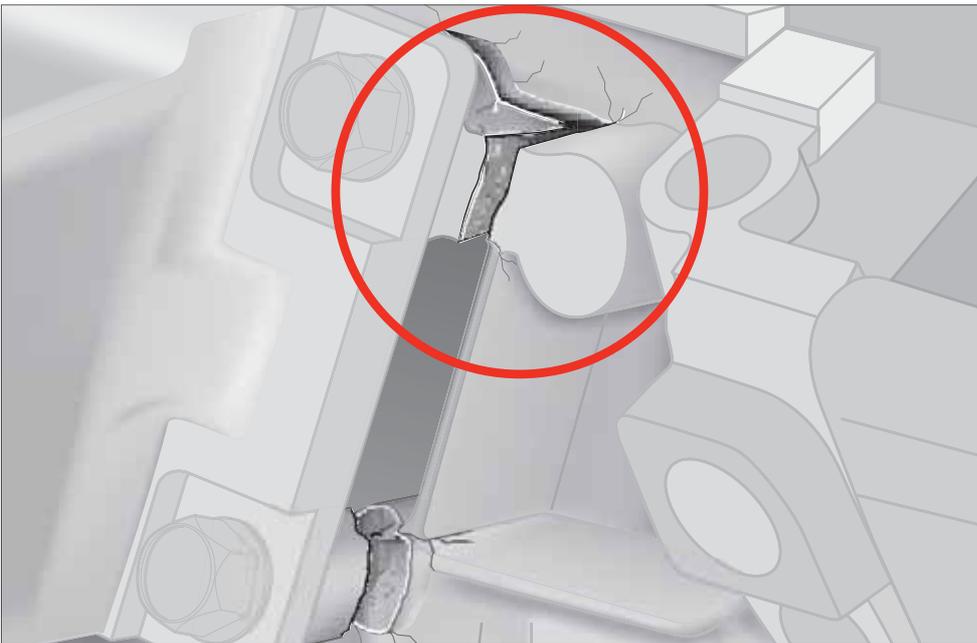
8.1 Engine mount – fractured

View of fractured engine and mount induced by a collision.

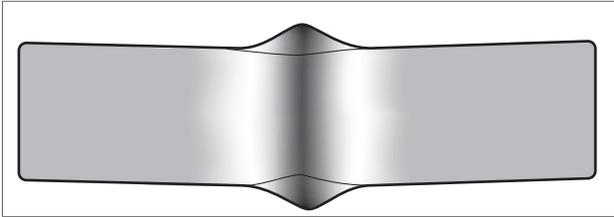
Buckle (top view)

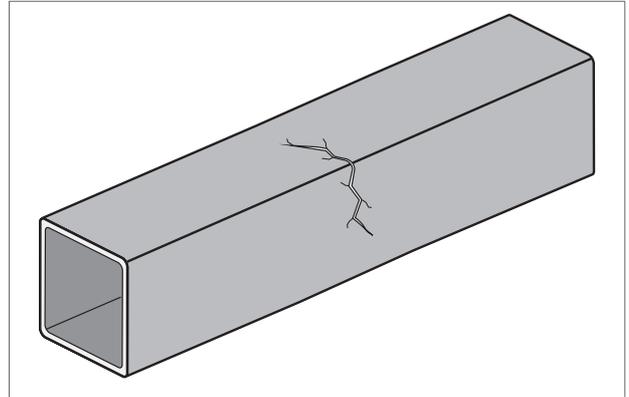
Cracked

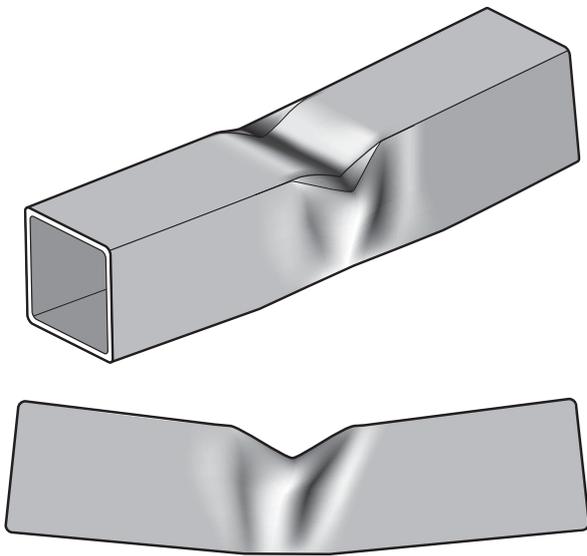
Buckle (side view)

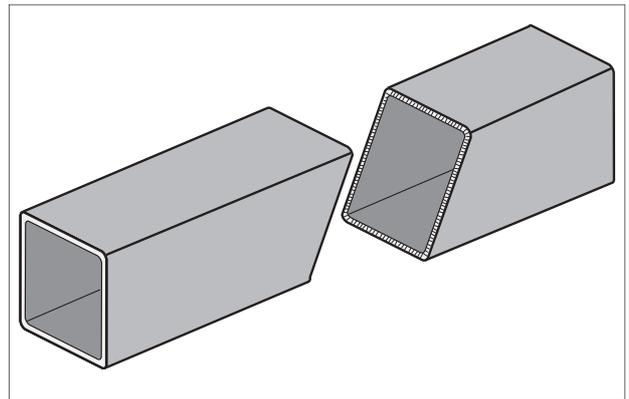
Cut

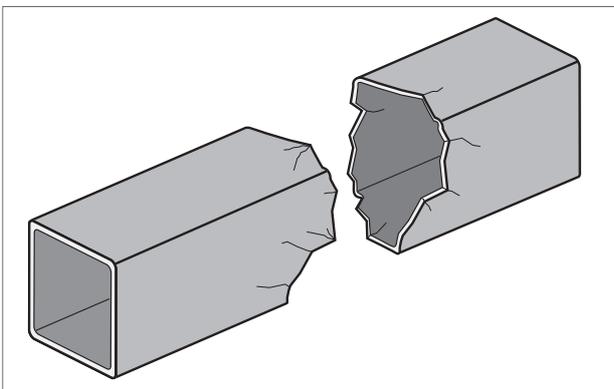
Fractured
