Damage Assessment Criteria for the Classification of Light Vehicle Statutory Write-Offs

National Motor Vehicle
Theft Reduction
Council

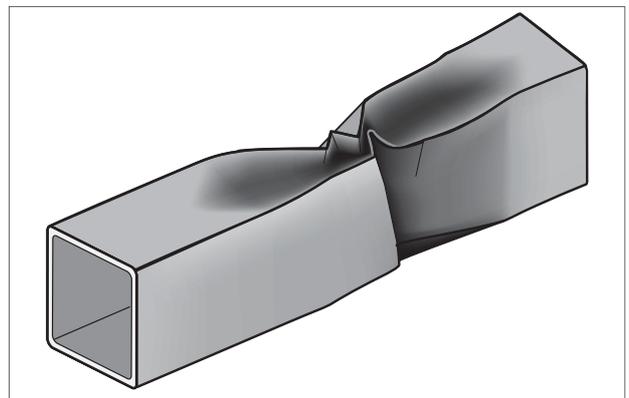
Folded
