Damage Assessment Criteria for the Classification of Statutory Write-Offs

National Motor Vehicle
Theft Reduction Council

Austroads

Published July 2011

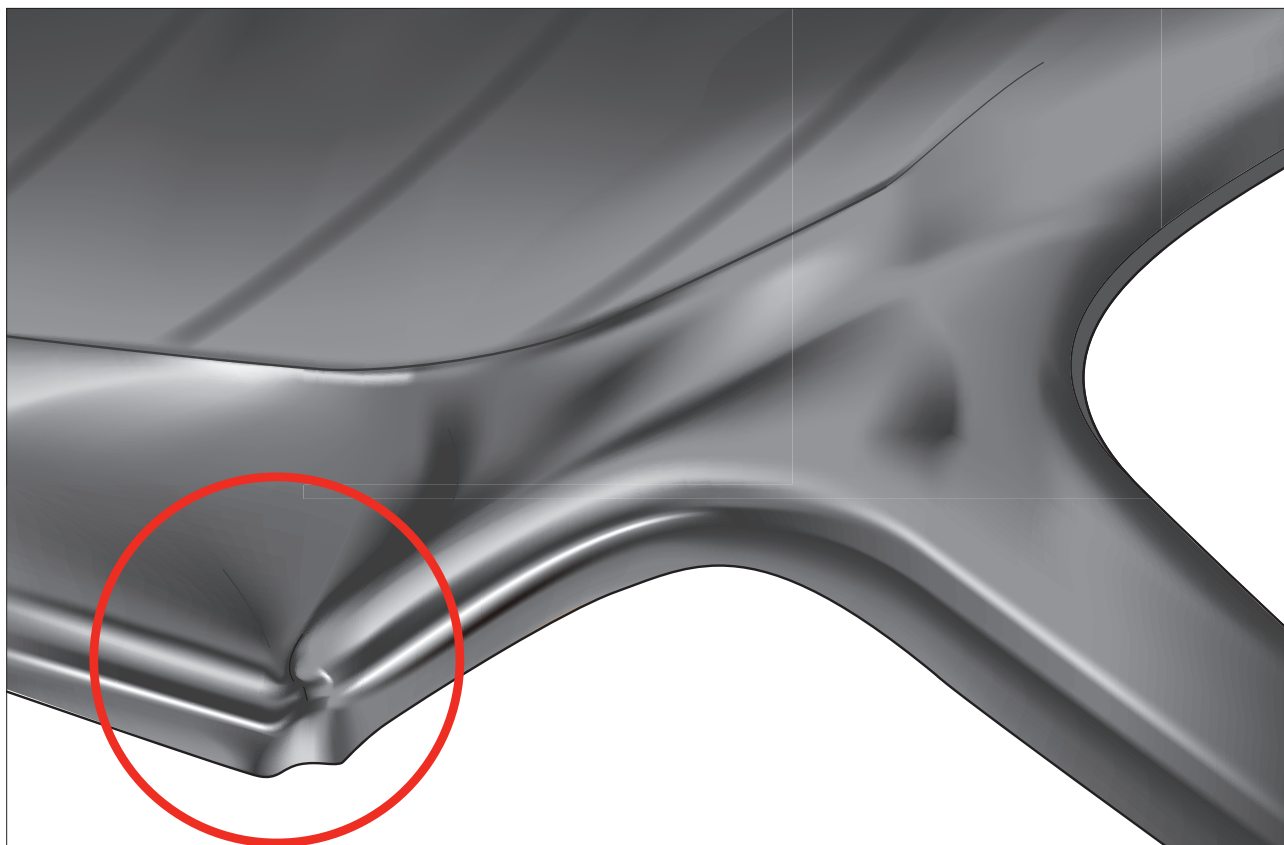
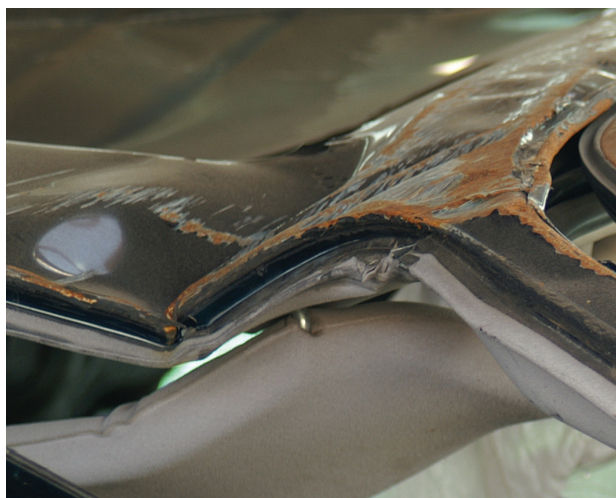
1.1 Roof – buckled

View of the roof, windscreen header, front left door header and 'A' pillar. The roof has been structurally loaded such that the windscreen header has buckled.

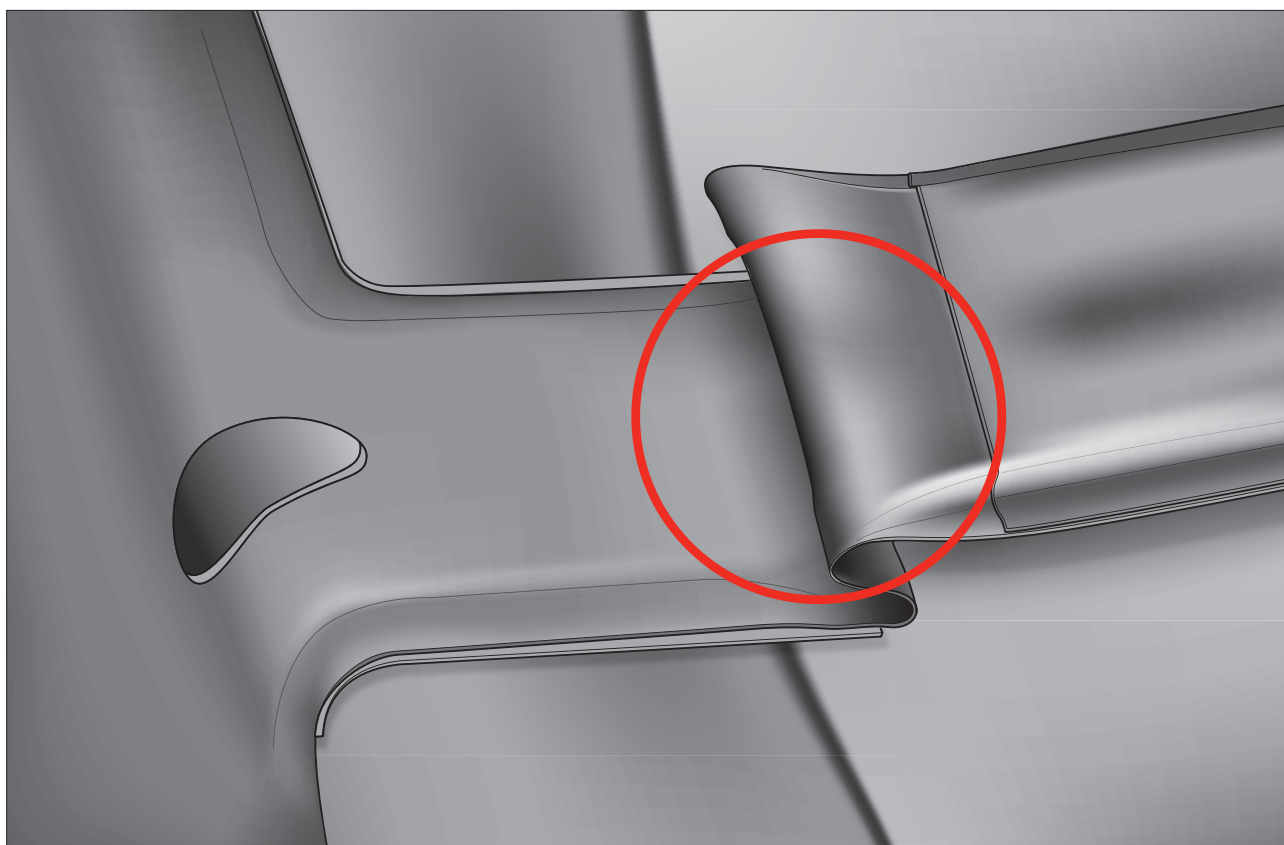
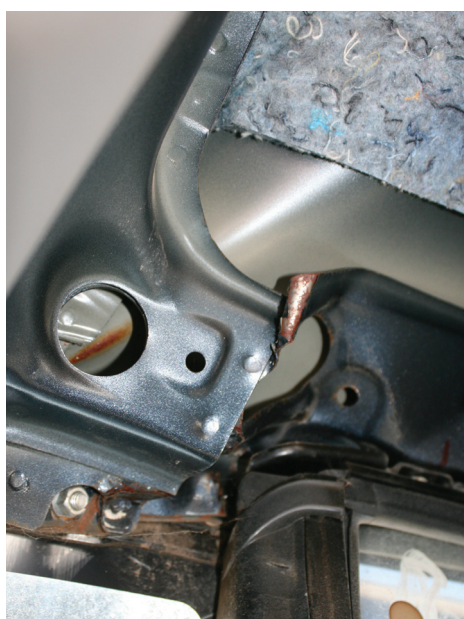
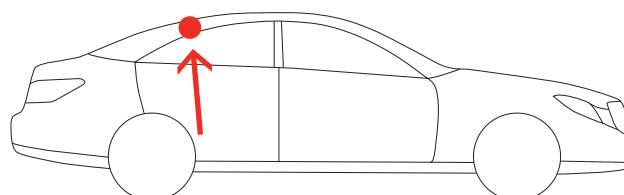
1.2 Roof support rail – folded

Internal view of lateral roof rail which due to structural loading has folded over onto itself.

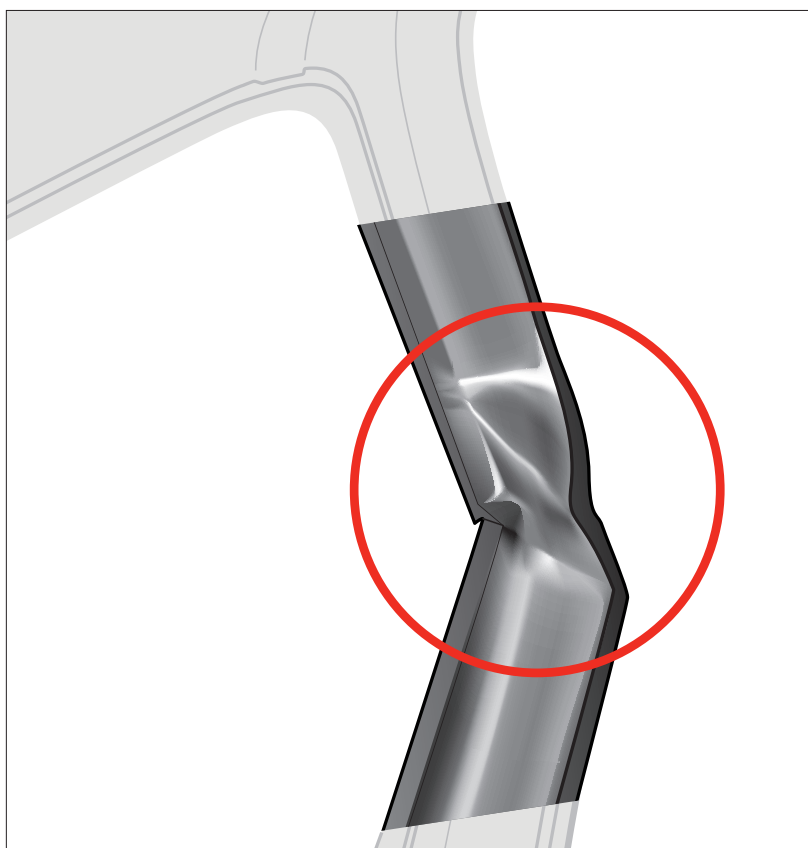
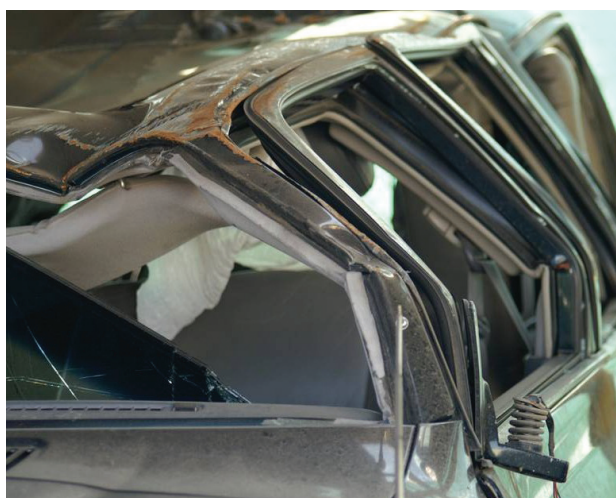
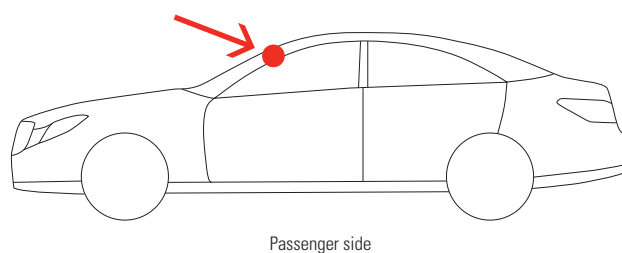
2.1 'A' pillar – buckled

A vehicle 'A' pillar which has failed by buckling due to structural loads to the roof.

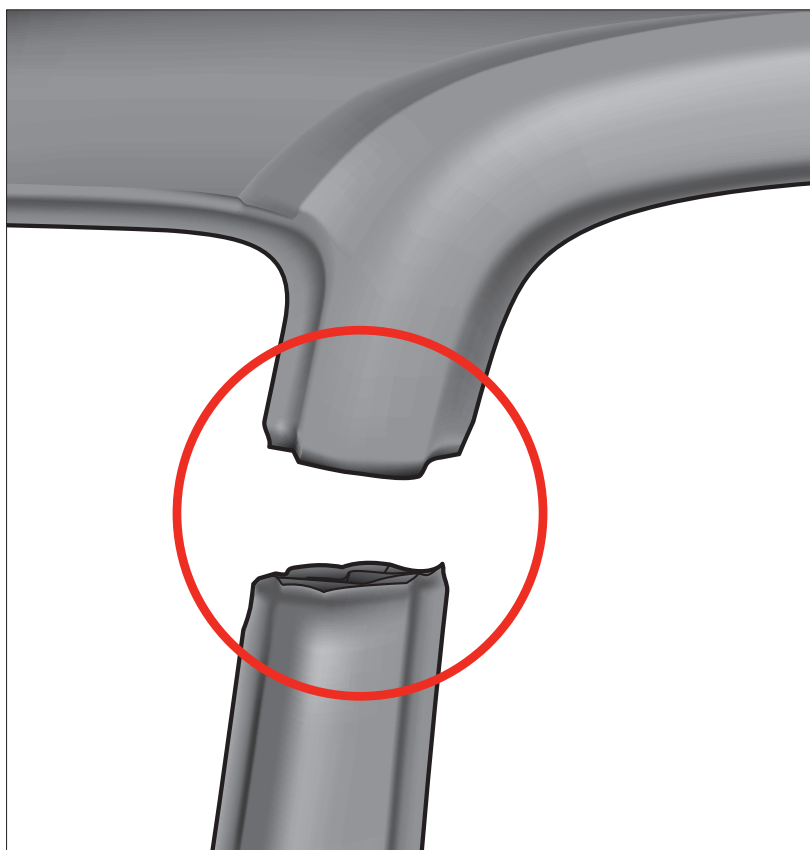
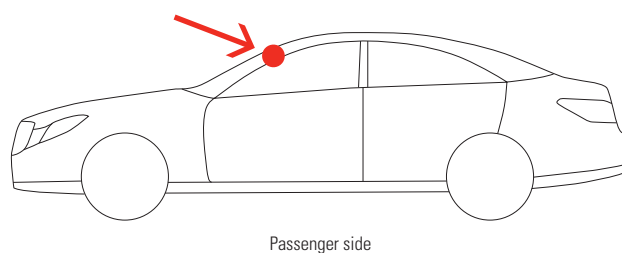
2.2 'A' pillar – cut

The 'A' pillar of a vehicle which has been cut (e.g. by emergency services personnel to permit occupant extraction).

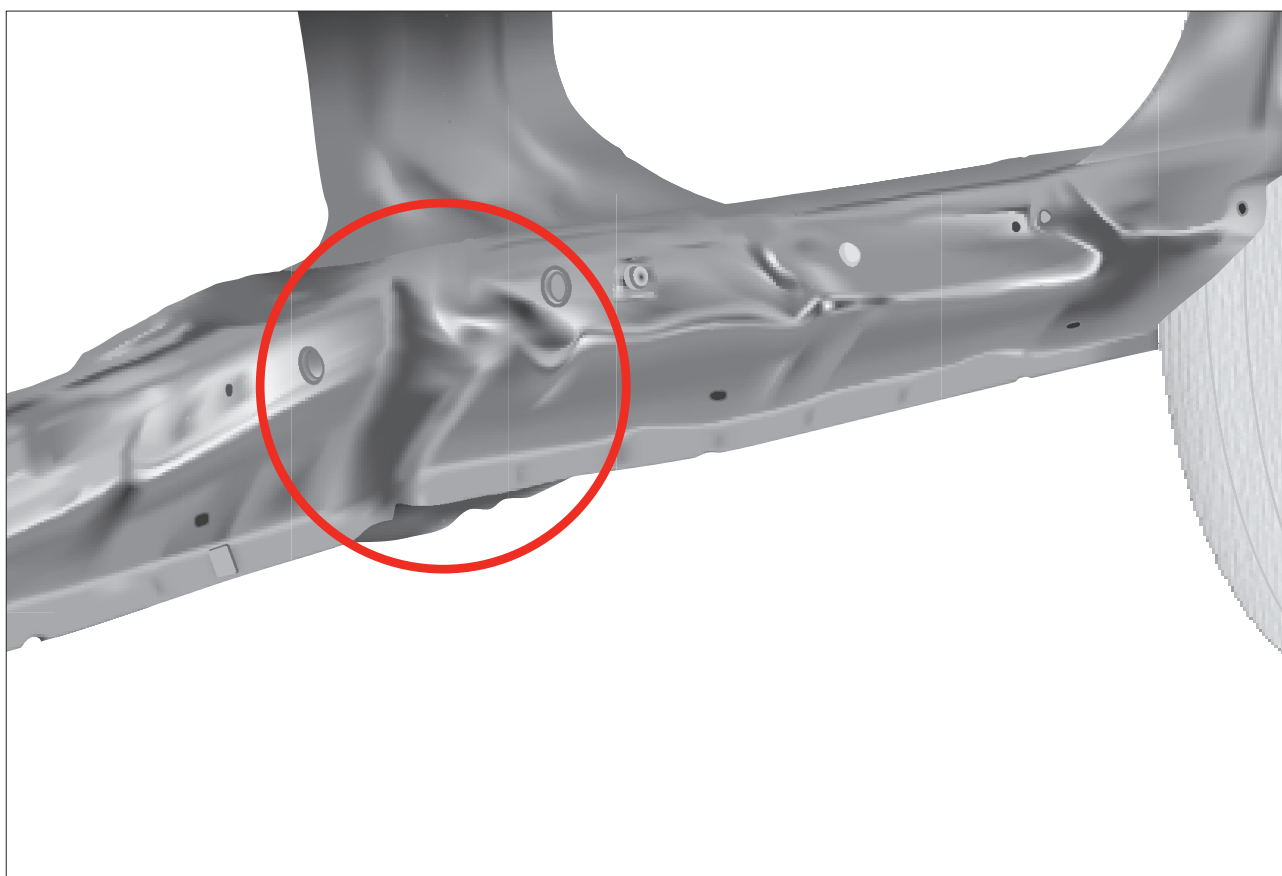
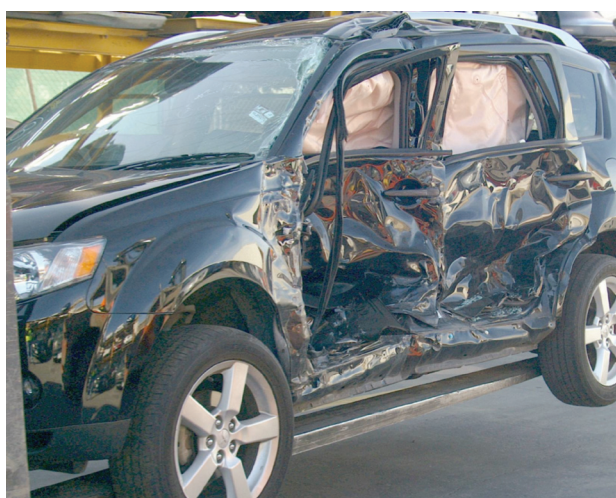
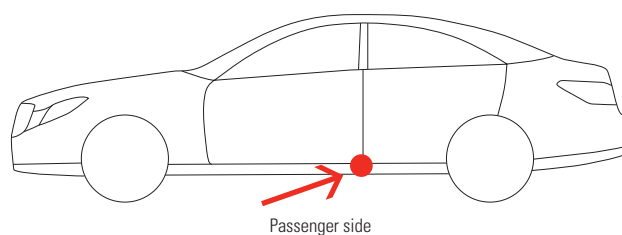
3.1 Floor pan – buckled

A side view of a vehicle showing buckling and folding of the floor.

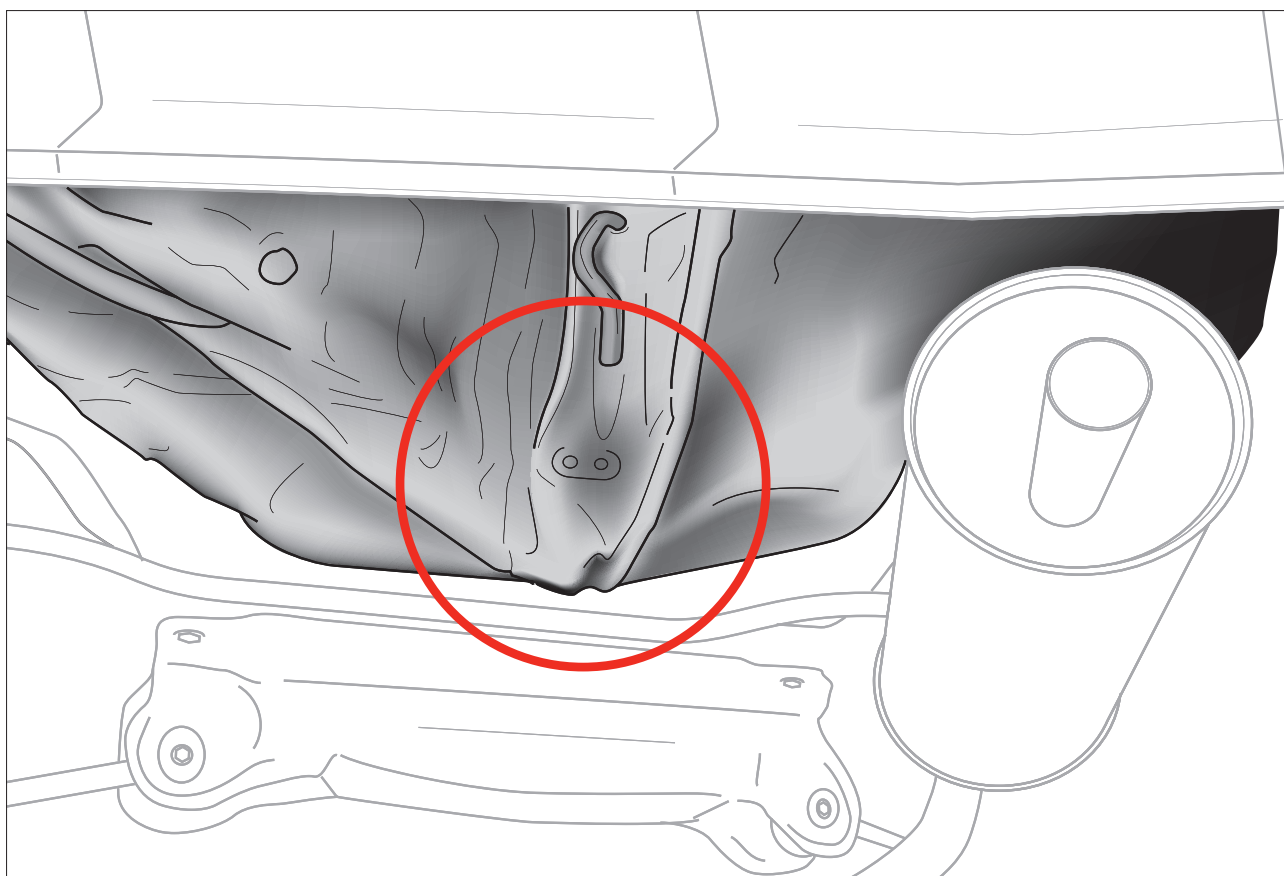
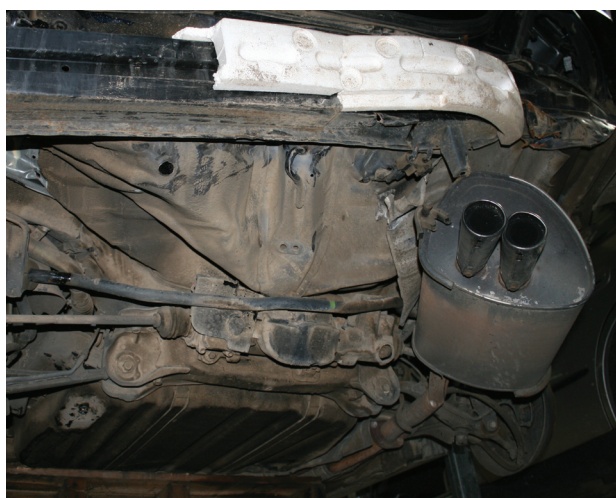
3.2 Floor pan – buckled

View of the rear underneath of a vehicle showing buckling of the floor pan.

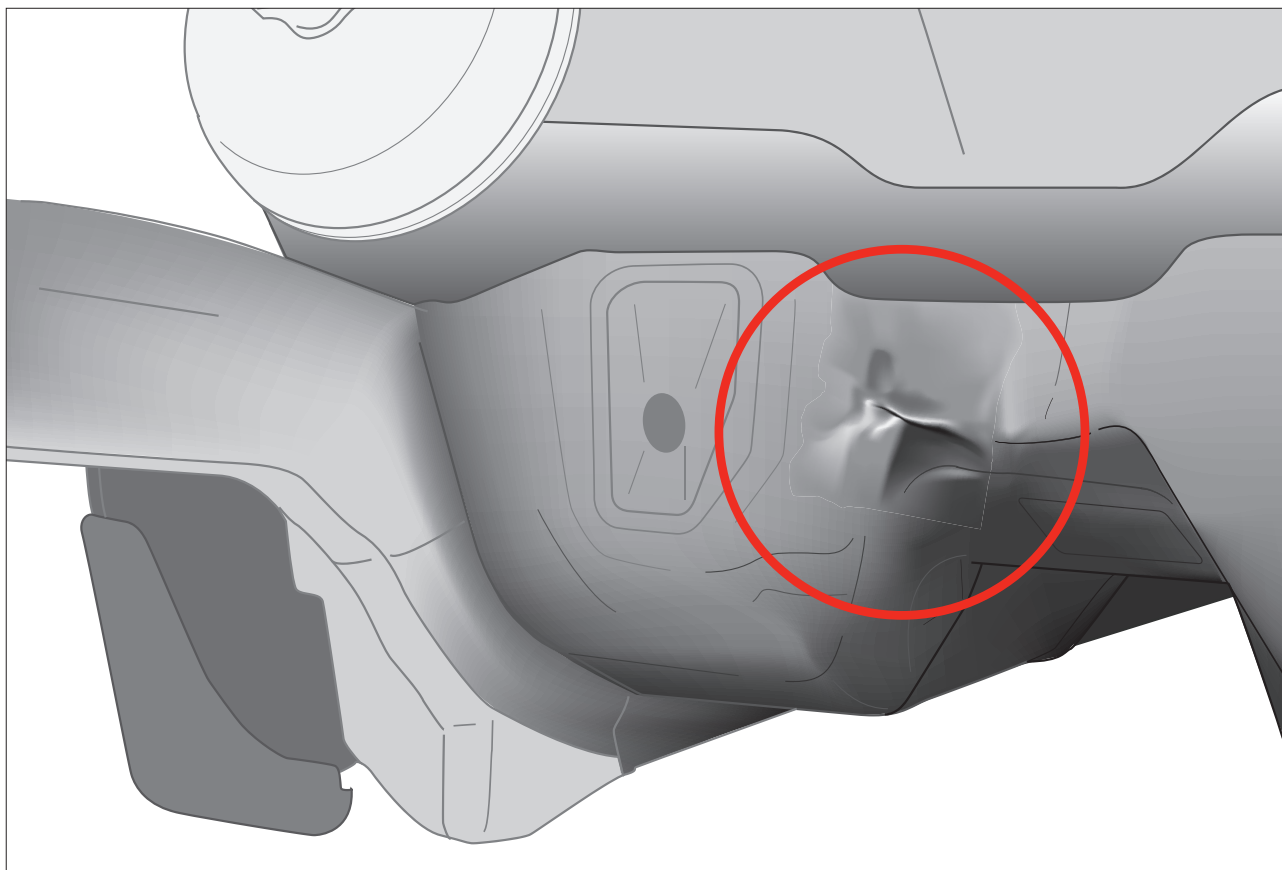
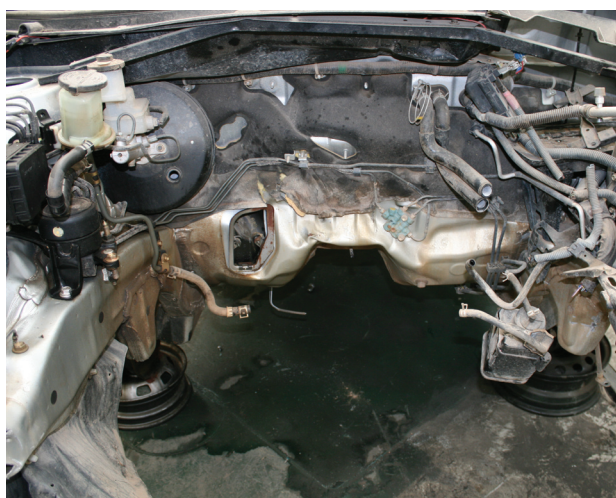
4.1 Firewall – folded

View of the firewall showing a fold induced by impact damage.

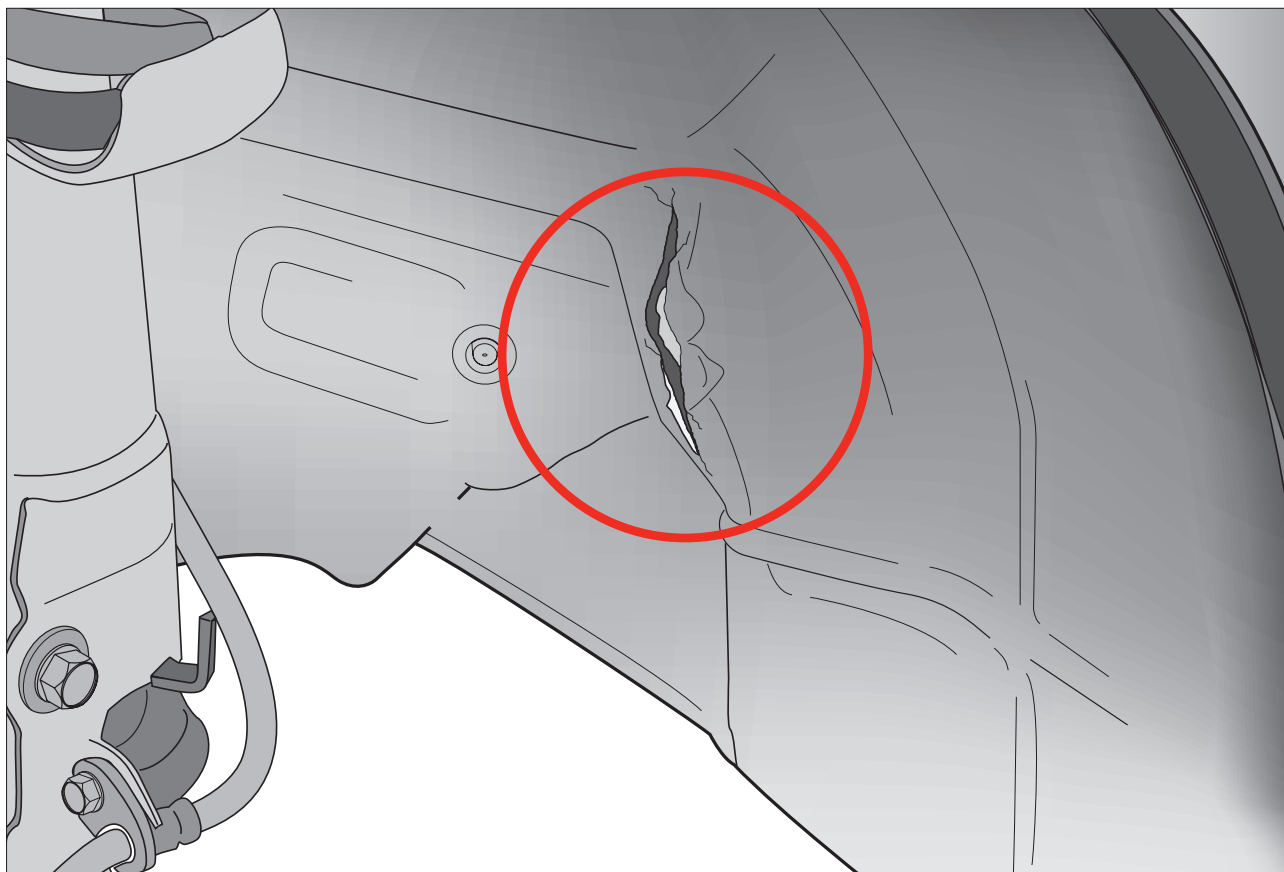
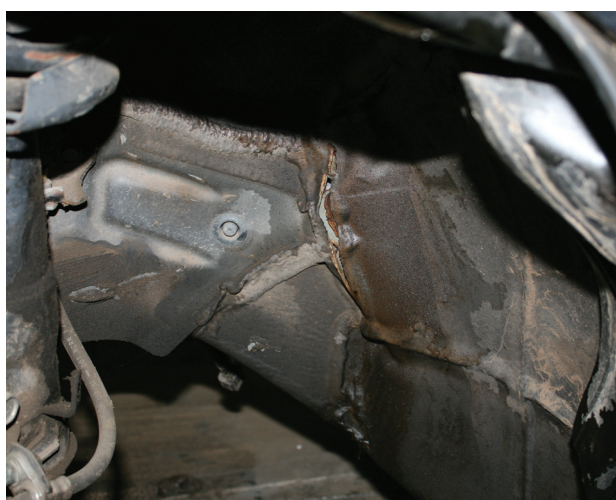
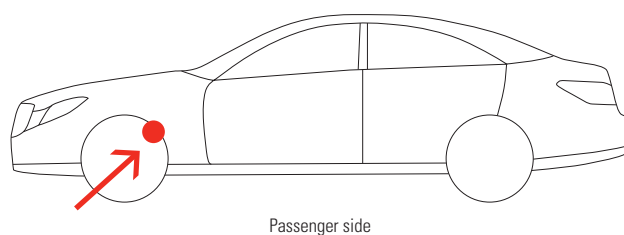
4.2 Firewall – cracked

View through the front left wheel-well of the firewall showing a crack in the firewall.

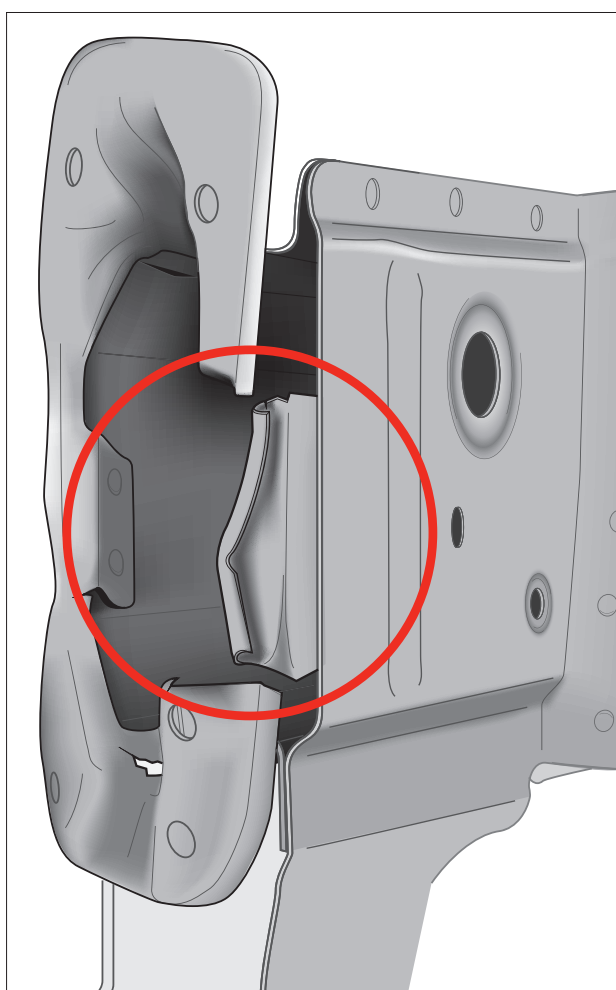
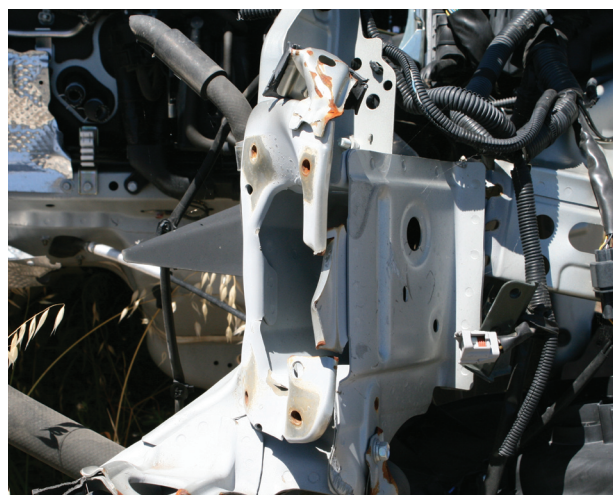
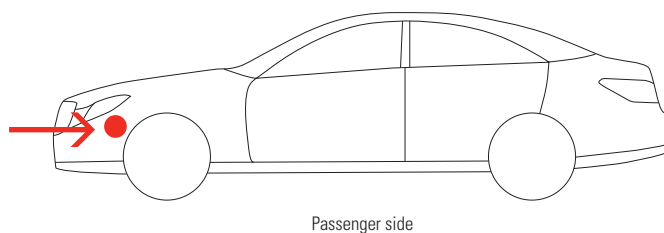
5.1 Chassis rail – fractured

View of longitudinal structural rail/chassis fractured due to impact.

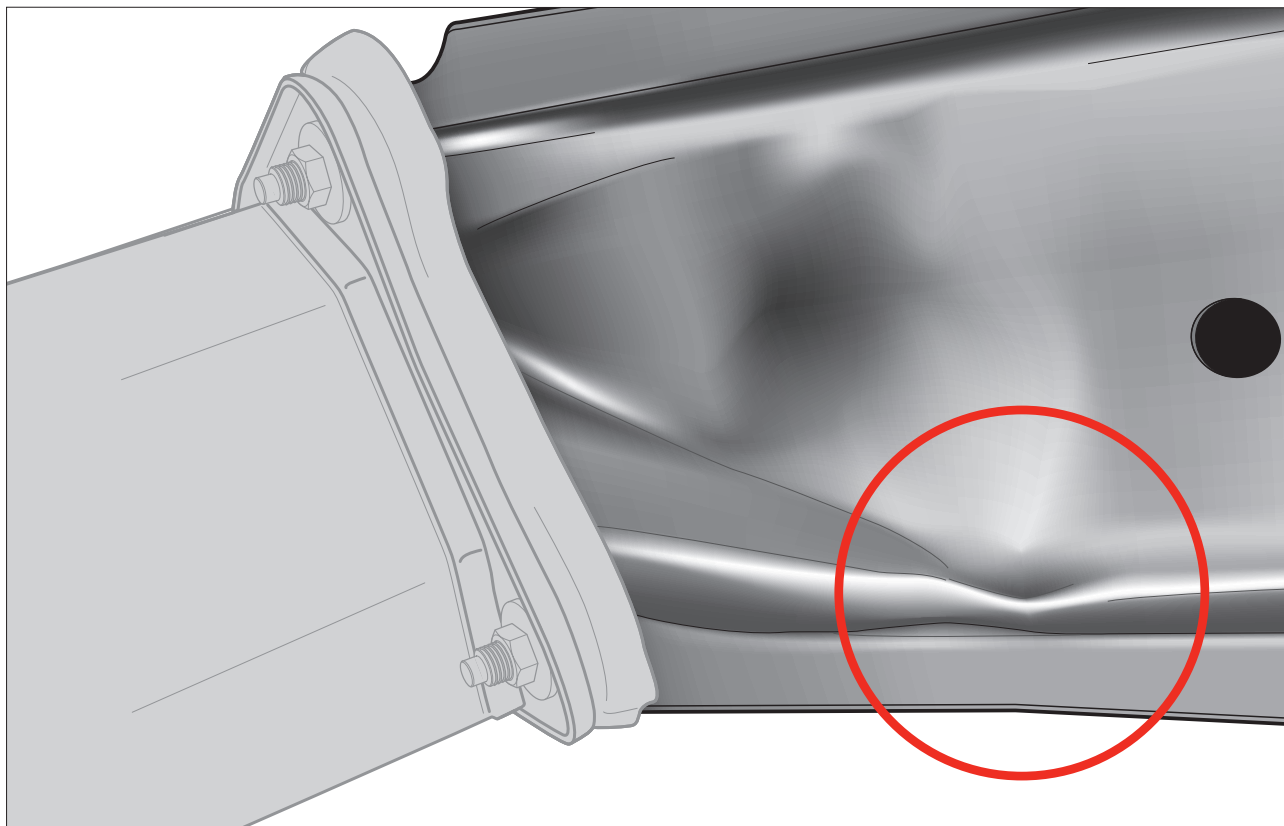
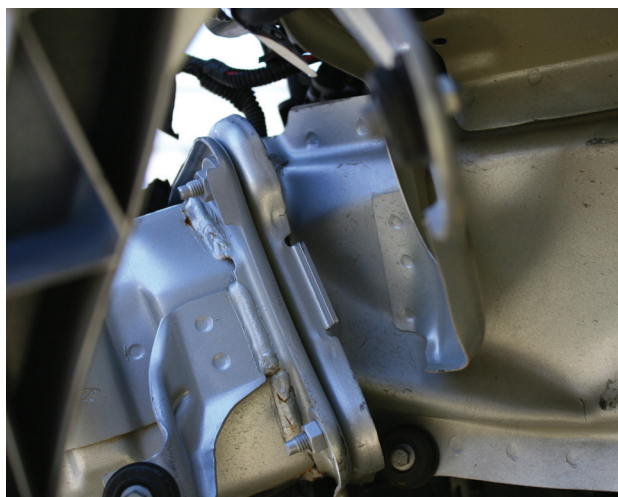
5.2 Chassis rail – buckled (side view)

View of a longitudinal structural/chassis rail which has buckled due to structural impact loading.

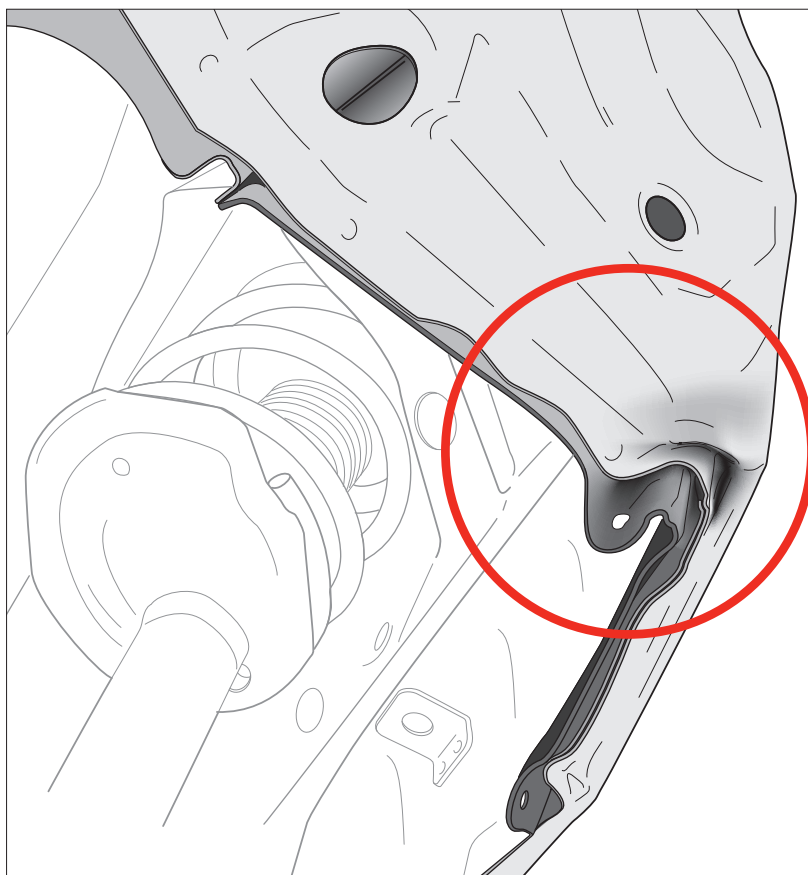
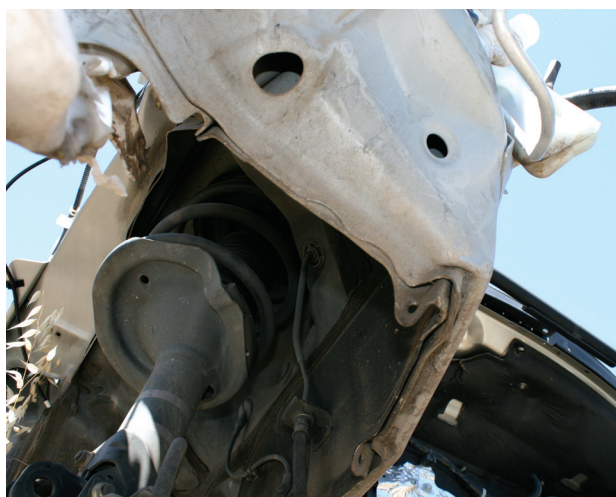
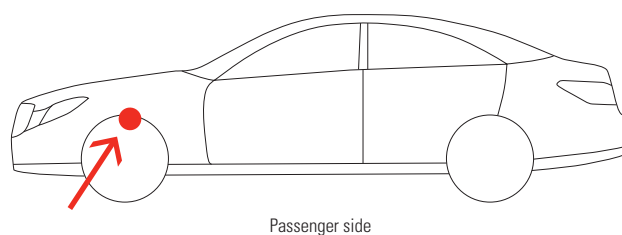
5.3 Chassis rail – folded

View of a longitudinal structural/chassis rail which has folded due to a side impact.

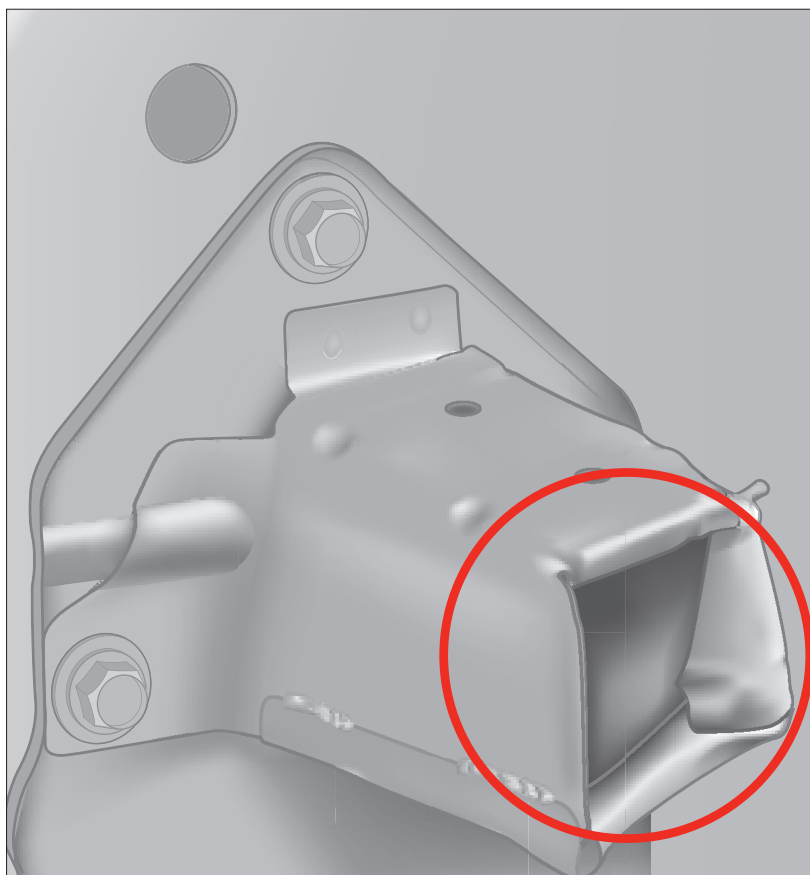
5.4 Deformable crush tube – damaged

This is an example of a deformable end plate that is designed to be removed and replaced. Such components are not to be registered as a damage count.

Note: A deformable member that is designed to be removed and replaced is not considered a fundamental structure of the vehicle if damaged and such components are not to be registered as a damage count.

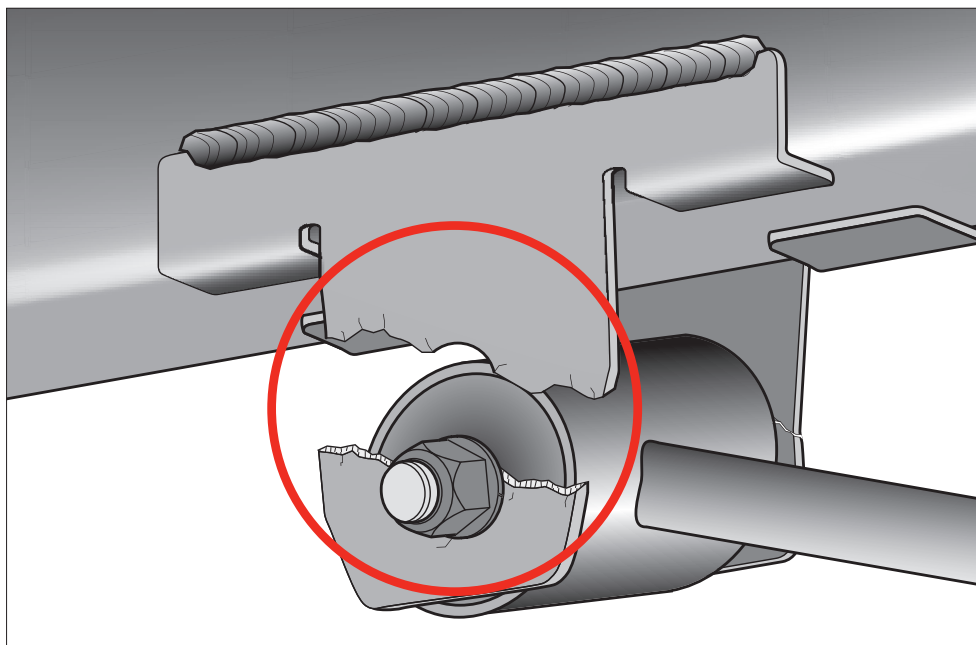
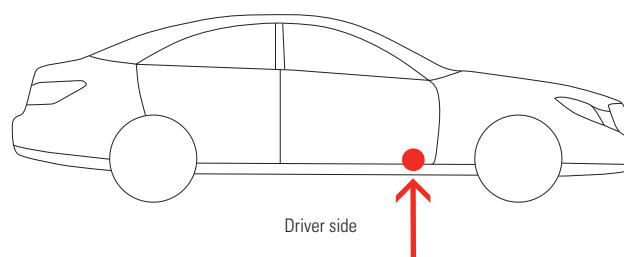
6.1 Suspension mount – fractured

View of a fractured suspension mount.

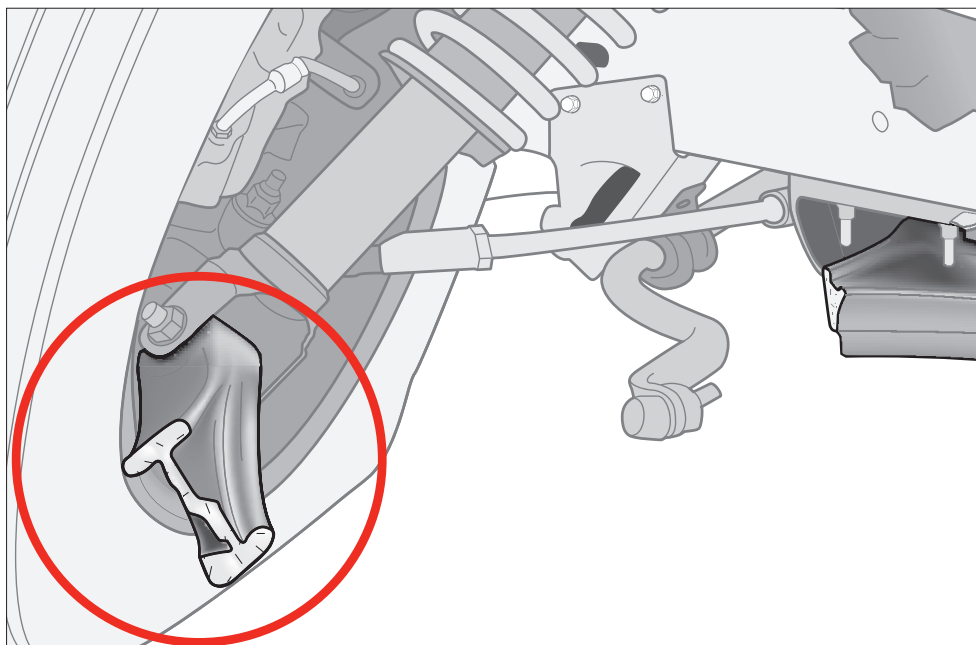
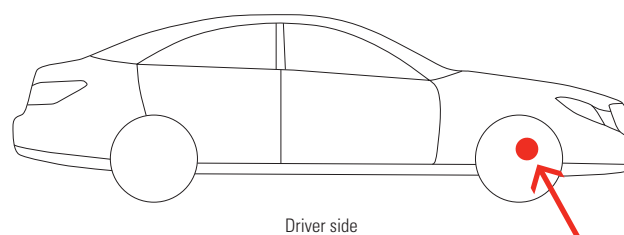
6.2 Suspension and linkages – damaged

This is an example of damaged suspension components that do not form part of the damage criteria because components such as suspension arms and linkages are designed to be removed and replaced.

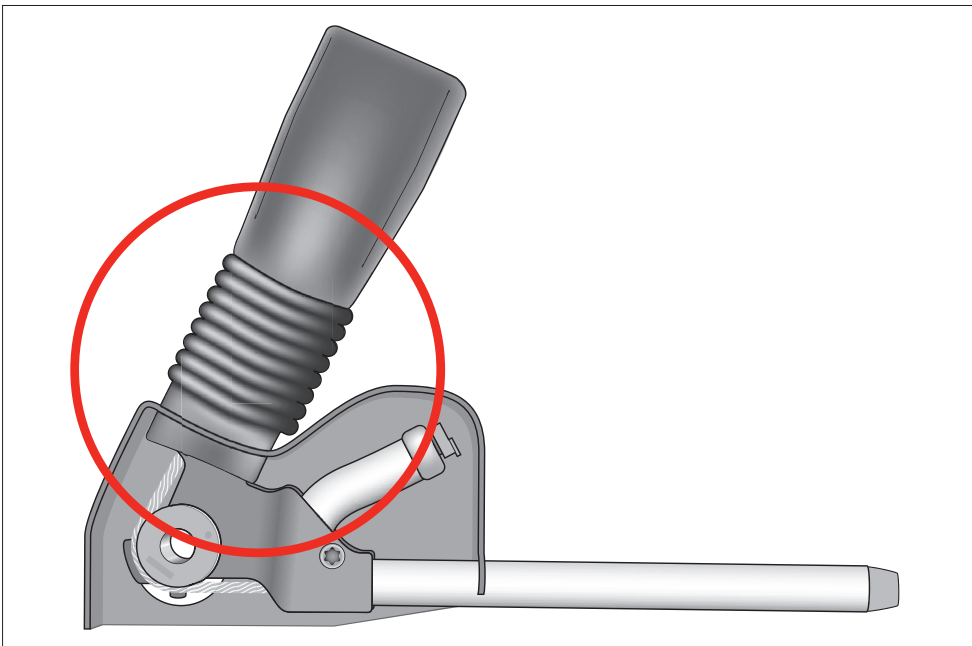
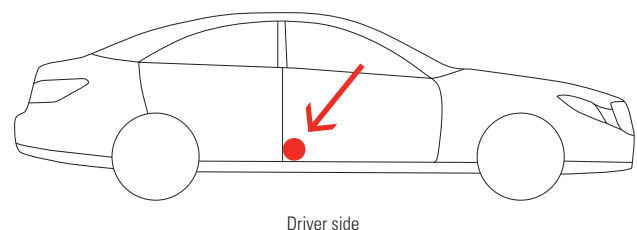
7.1 Pre-tensioner – active

View of a seat belt buckle showing a buckle with an active pre-tensioner.

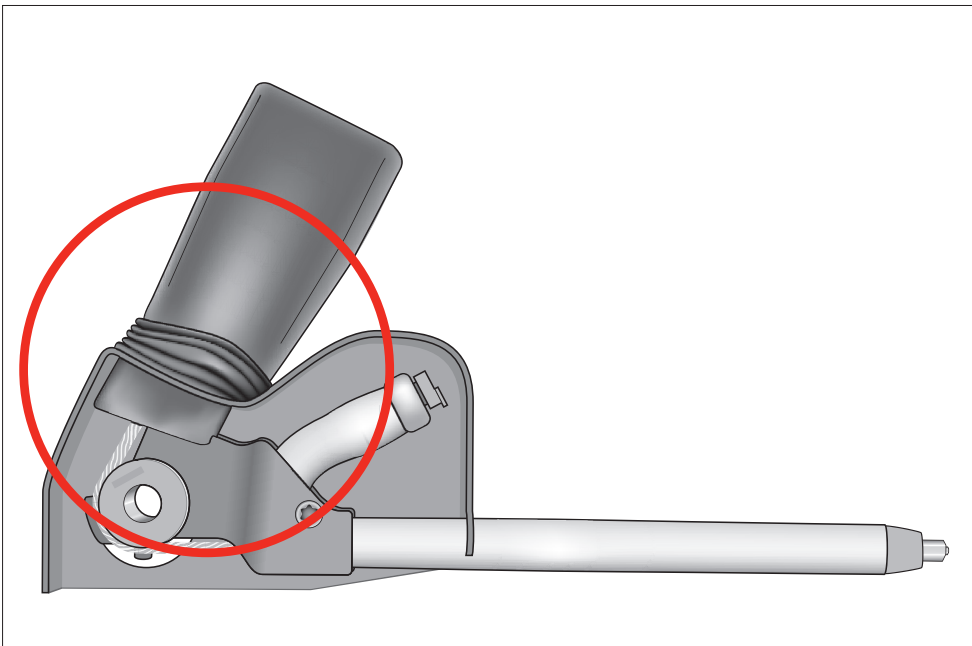
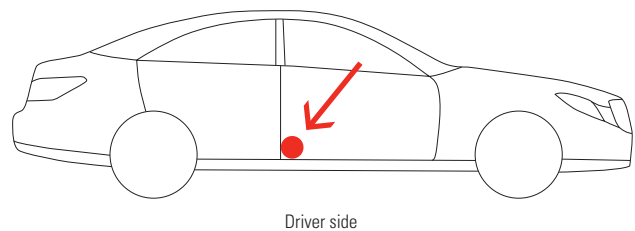
7.2 Pre-tensioner – fired

View of a seat belt buckle showing a buckle with a used pre-tensioner.

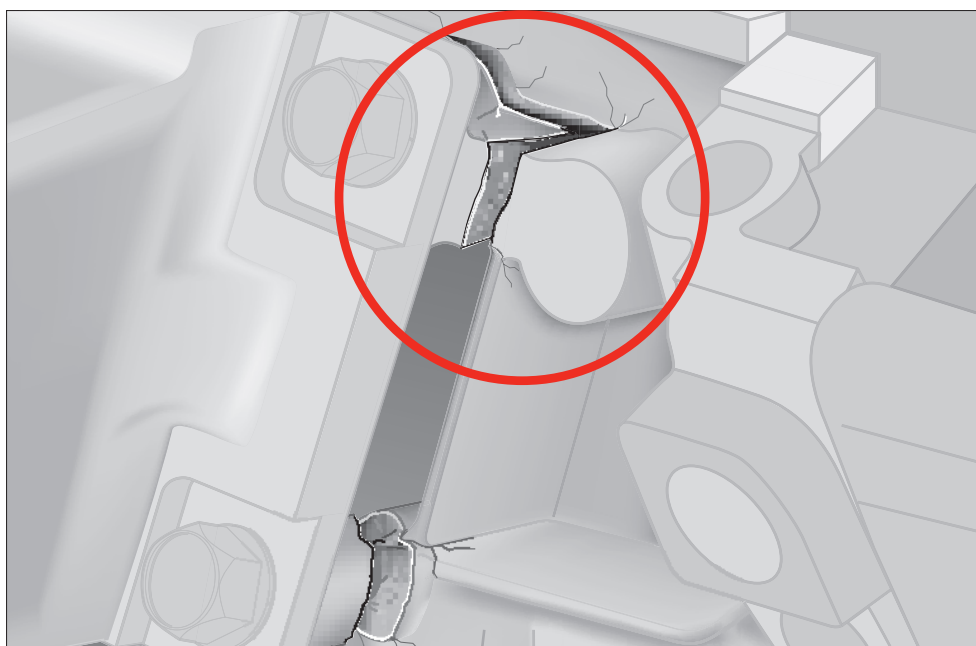
8.1 Engine mount – fractured

View of fractured engine and mount induced by a collision.

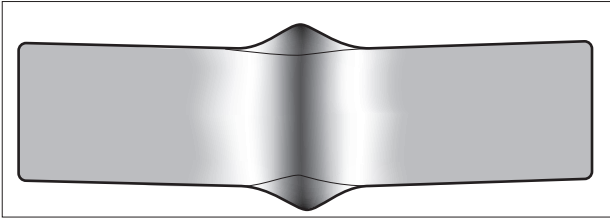
Buckle (top view)

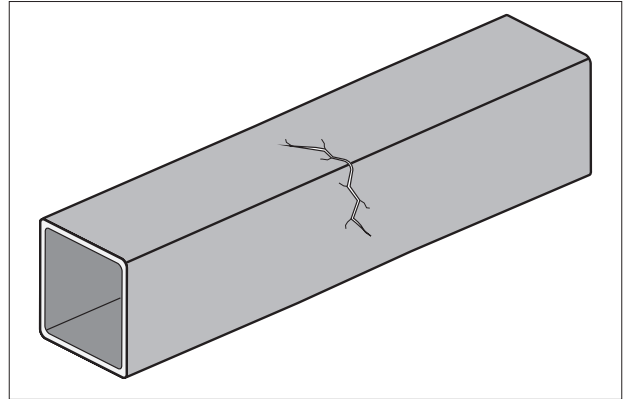
Cracked

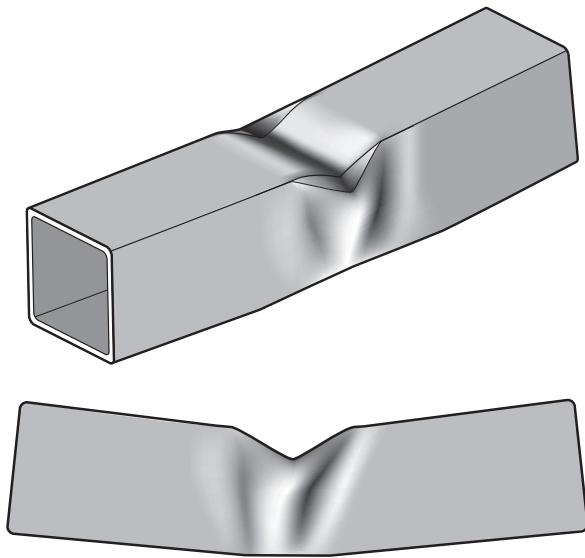
Buckle (side view)

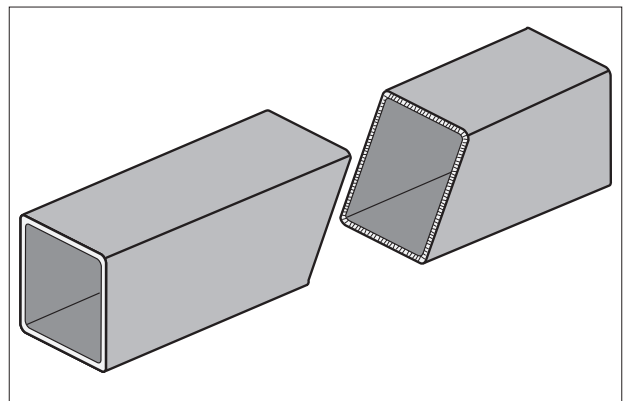
Cut

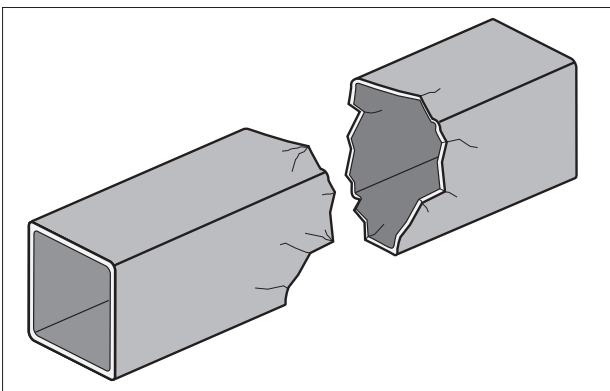
Fractured

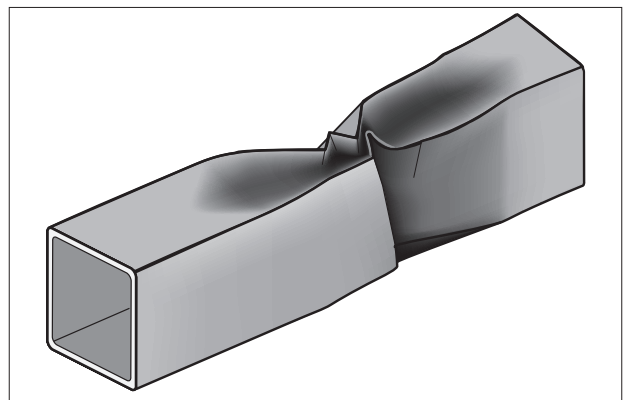
Folded
