Damage Assessment Criteria for the Classification of Statutory Write-Offs

National Motor Vehicle
Theft Reduction Council

Austroads

Published July 2011

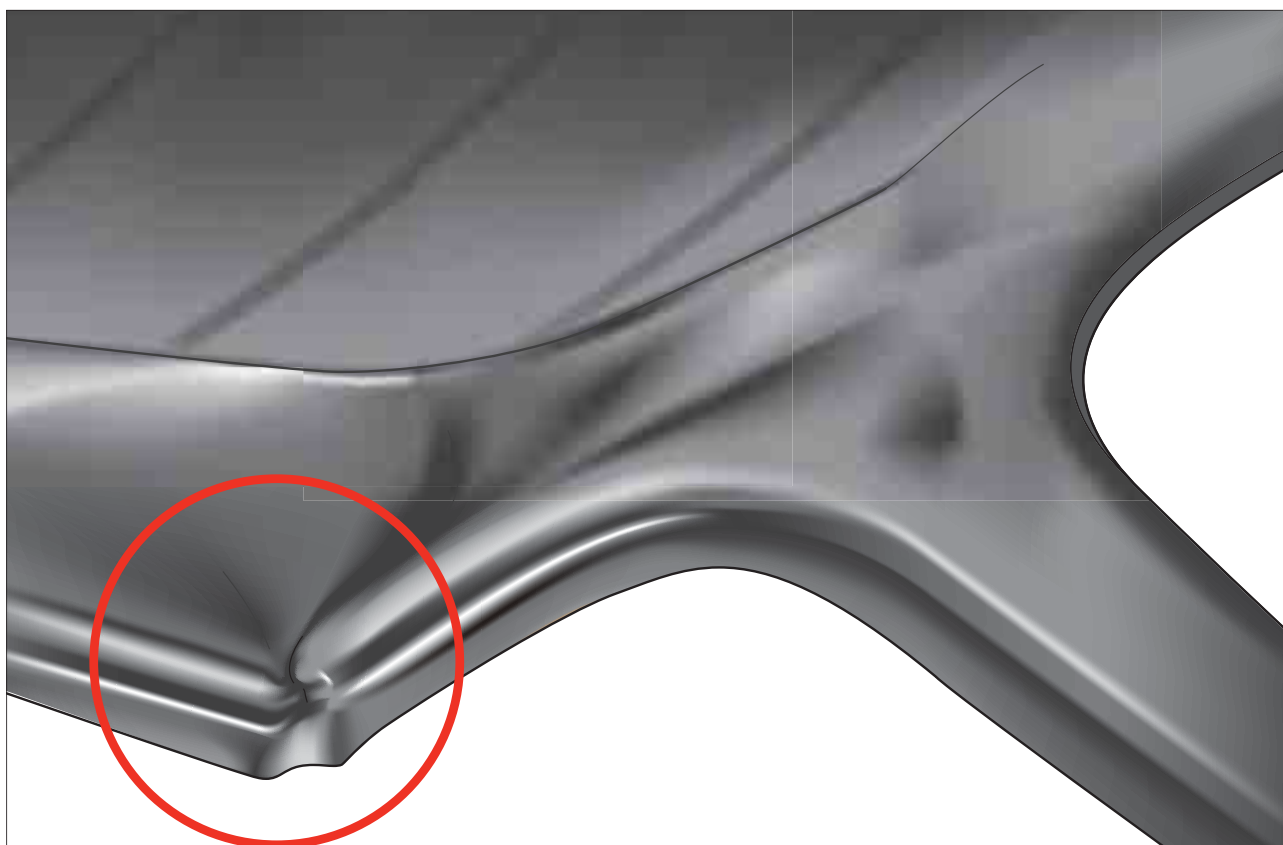
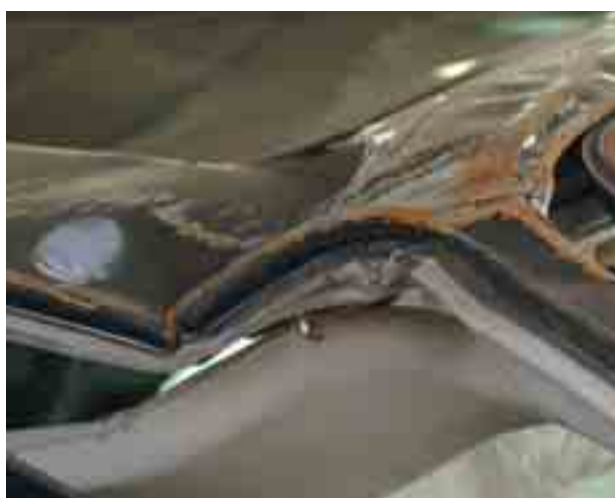
1.1 Roof – buckled

View of the roof, windscreen header, front left door header and 'A' pillar. The roof has been structurally loaded such that the windscreen header has buckled.

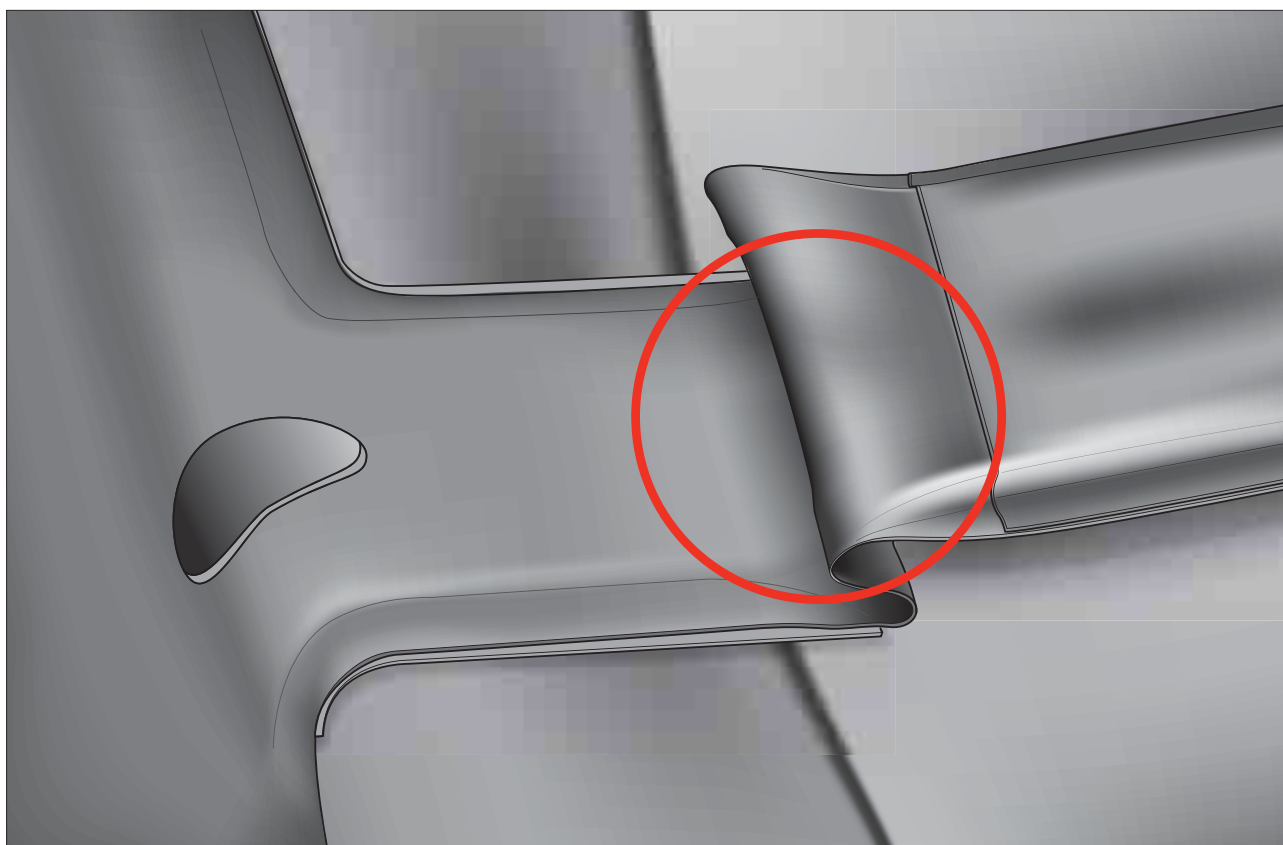
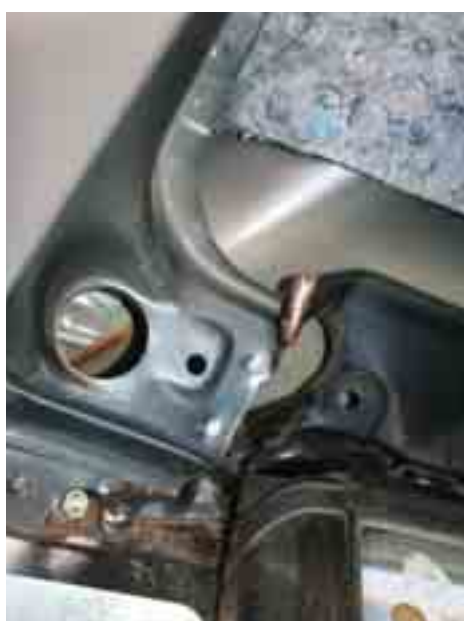
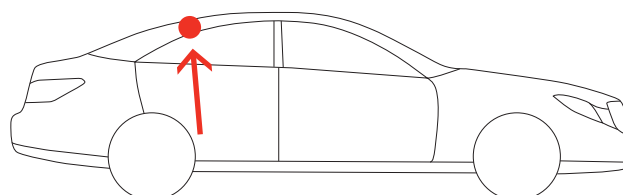
1.2 Roof support rail – folded

Internal view of lateral roof rail which due to structural loading has folded over onto itself.

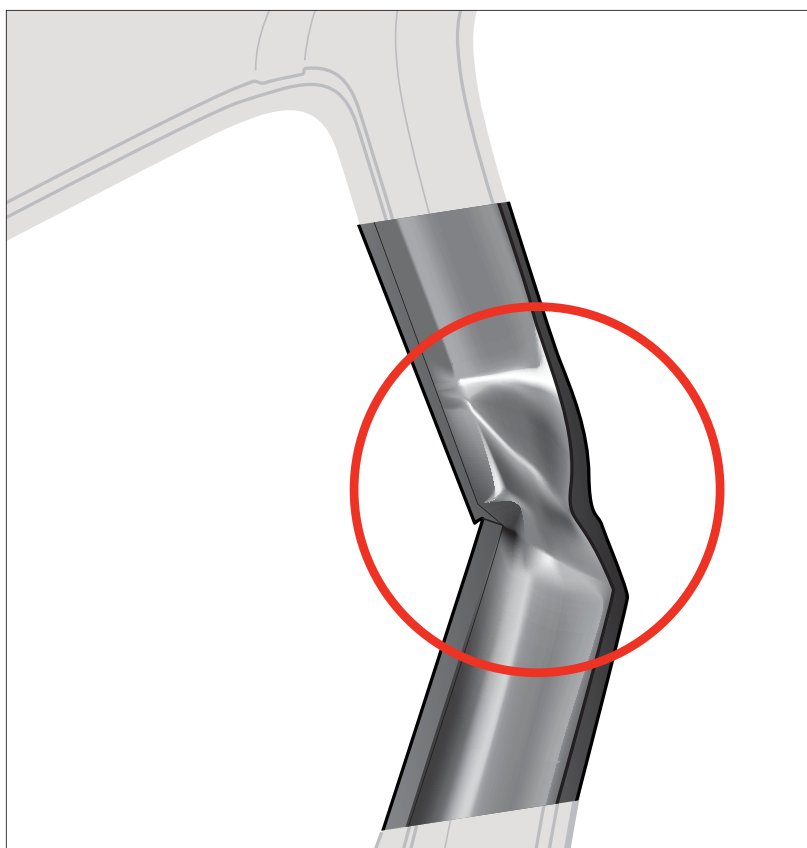
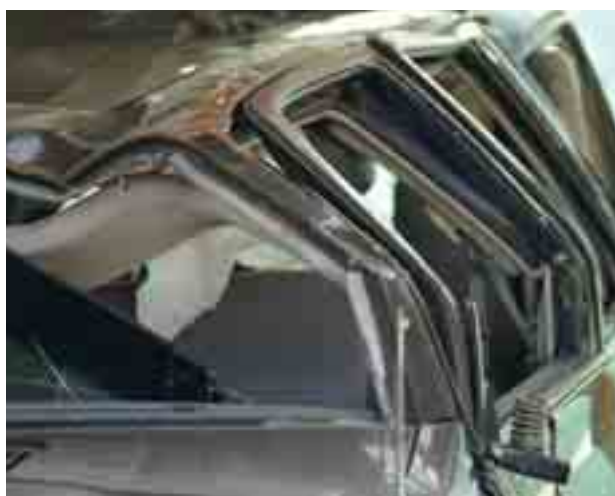
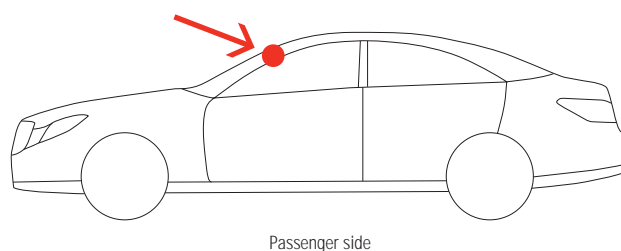
2.1 'A' pillar – buckled

A vehicle 'A' pillar which has failed by buckling due to structural loads to the roof.

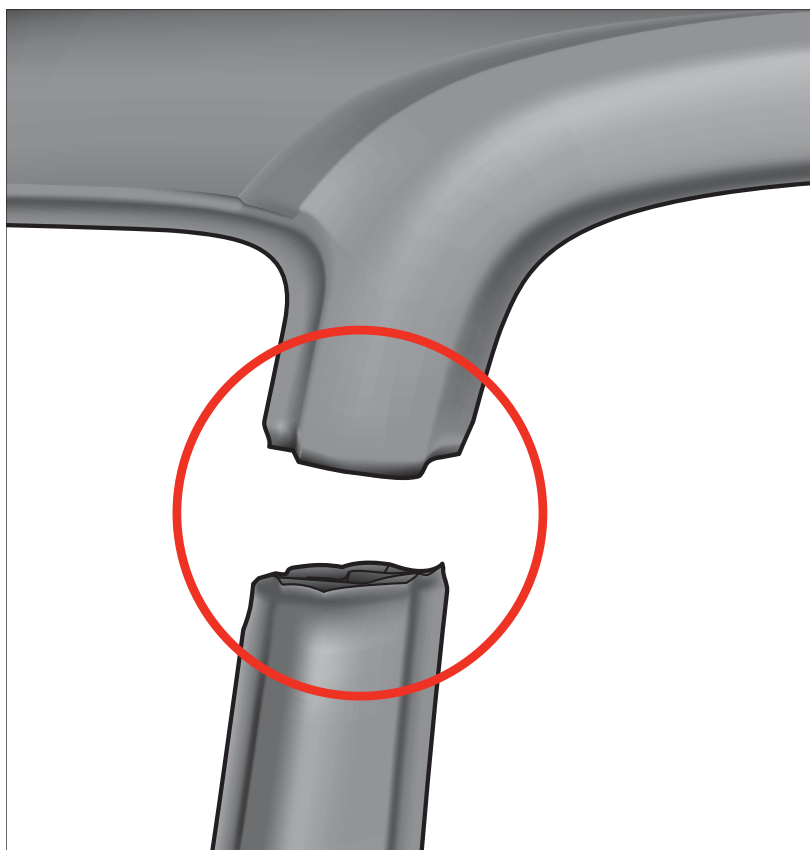
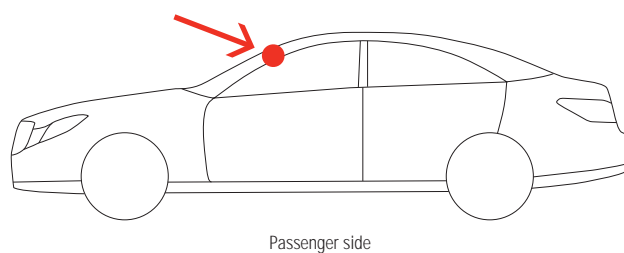
2.2 'A' pillar – cut

The 'A' pillar of a vehicle which has been cut (e.g. by emergency services personnel to permit occupant extraction).

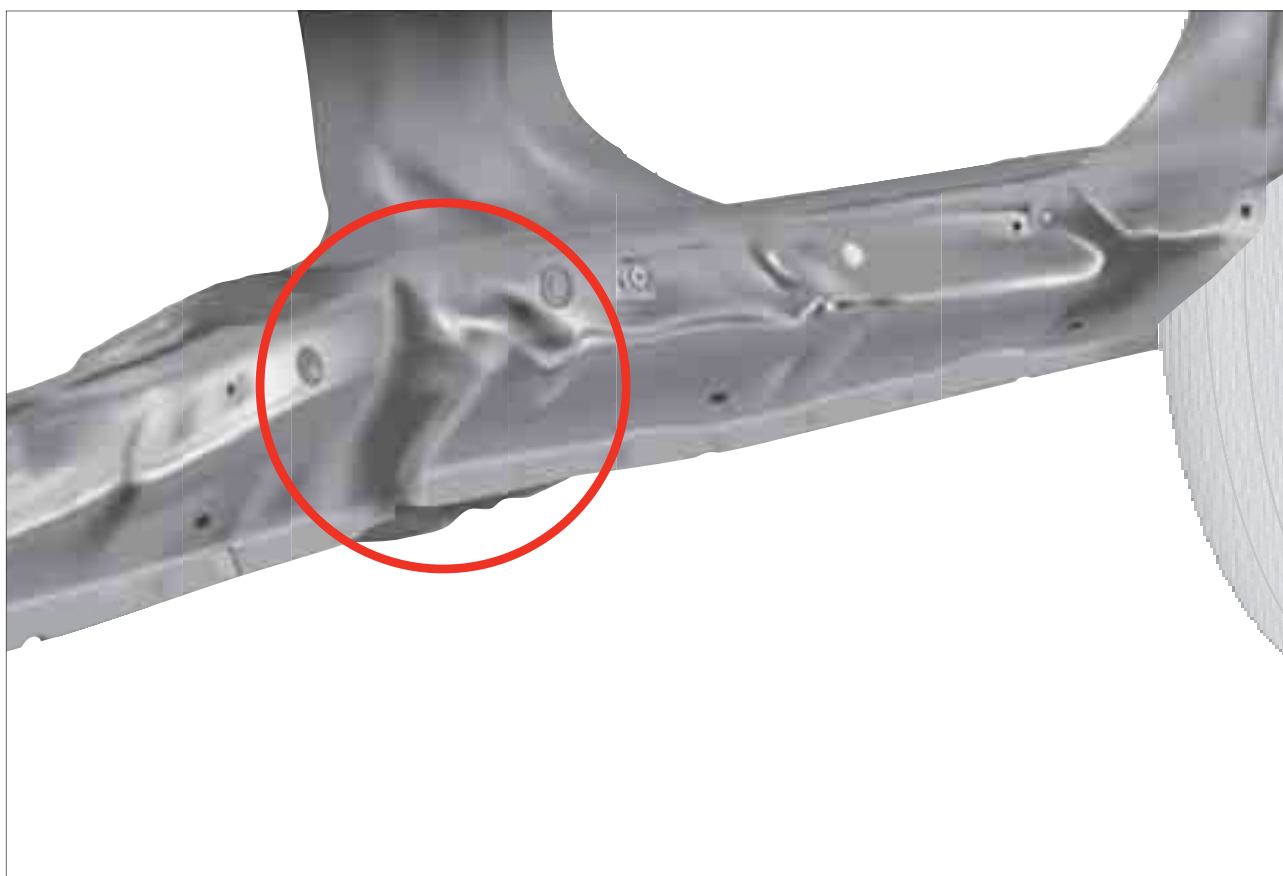
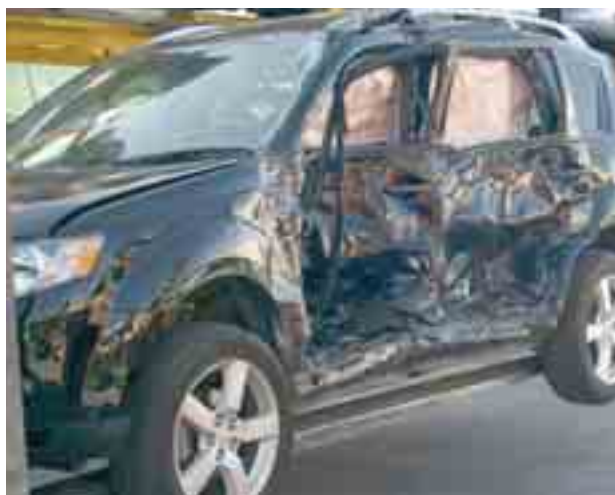
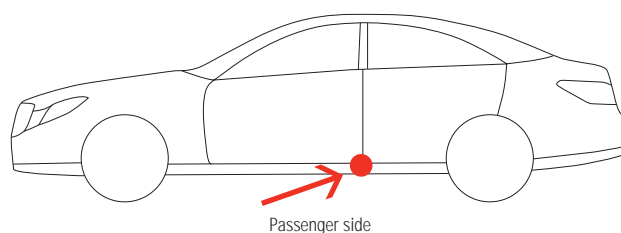
3.1 Floor pan – buckled

A side view of a vehicle showing buckling and folding of the floor.

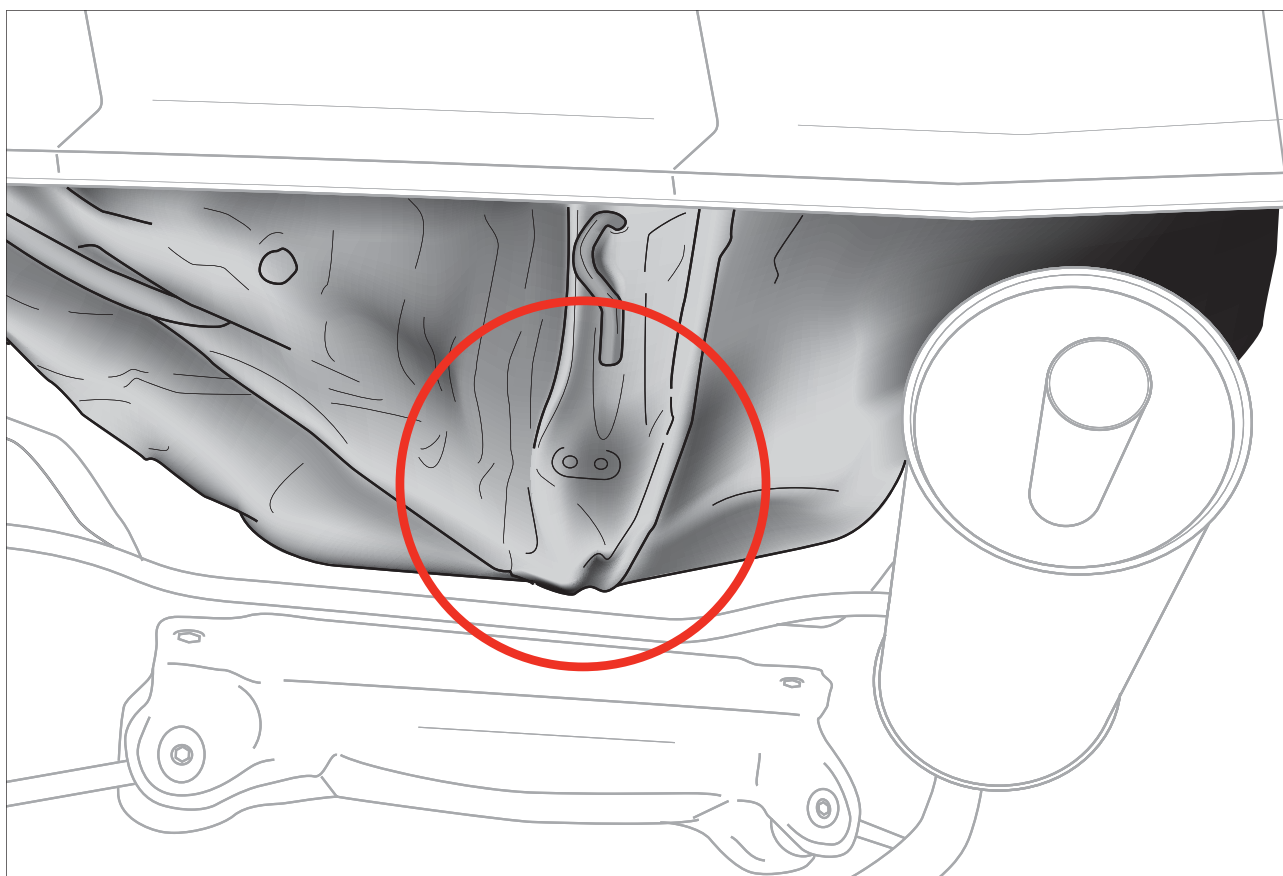
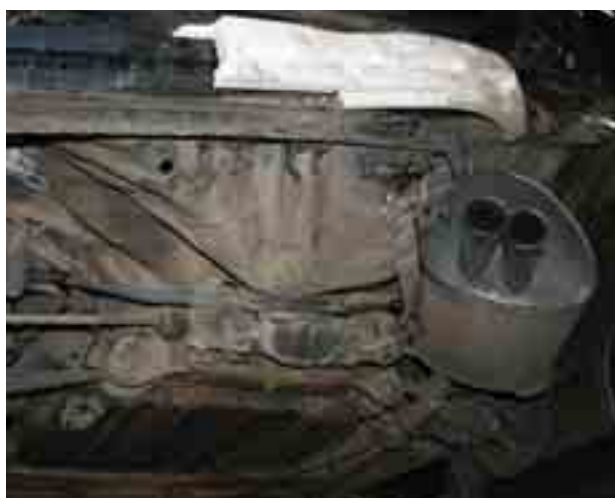
3.2 Floor pan – buckled

View of the rear underneath of a vehicle showing buckling of the floor pan.

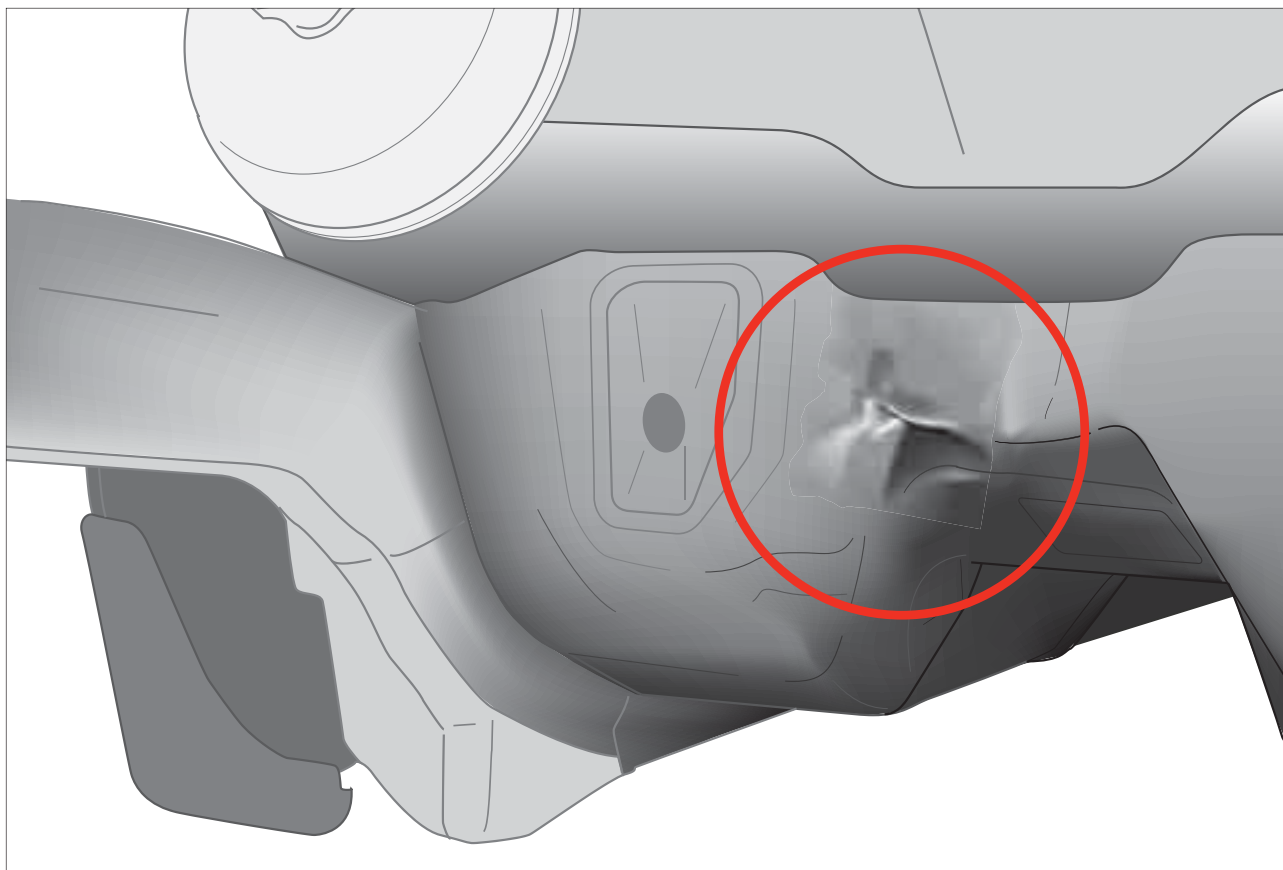
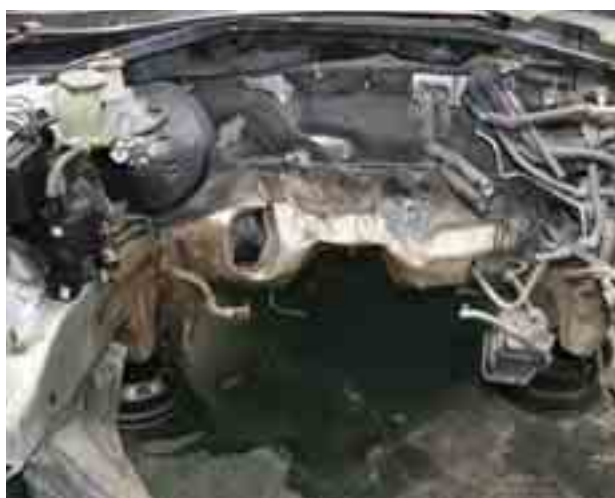
4.1 Firewall – folded

View of the firewall showing a fold induced by impact damage.

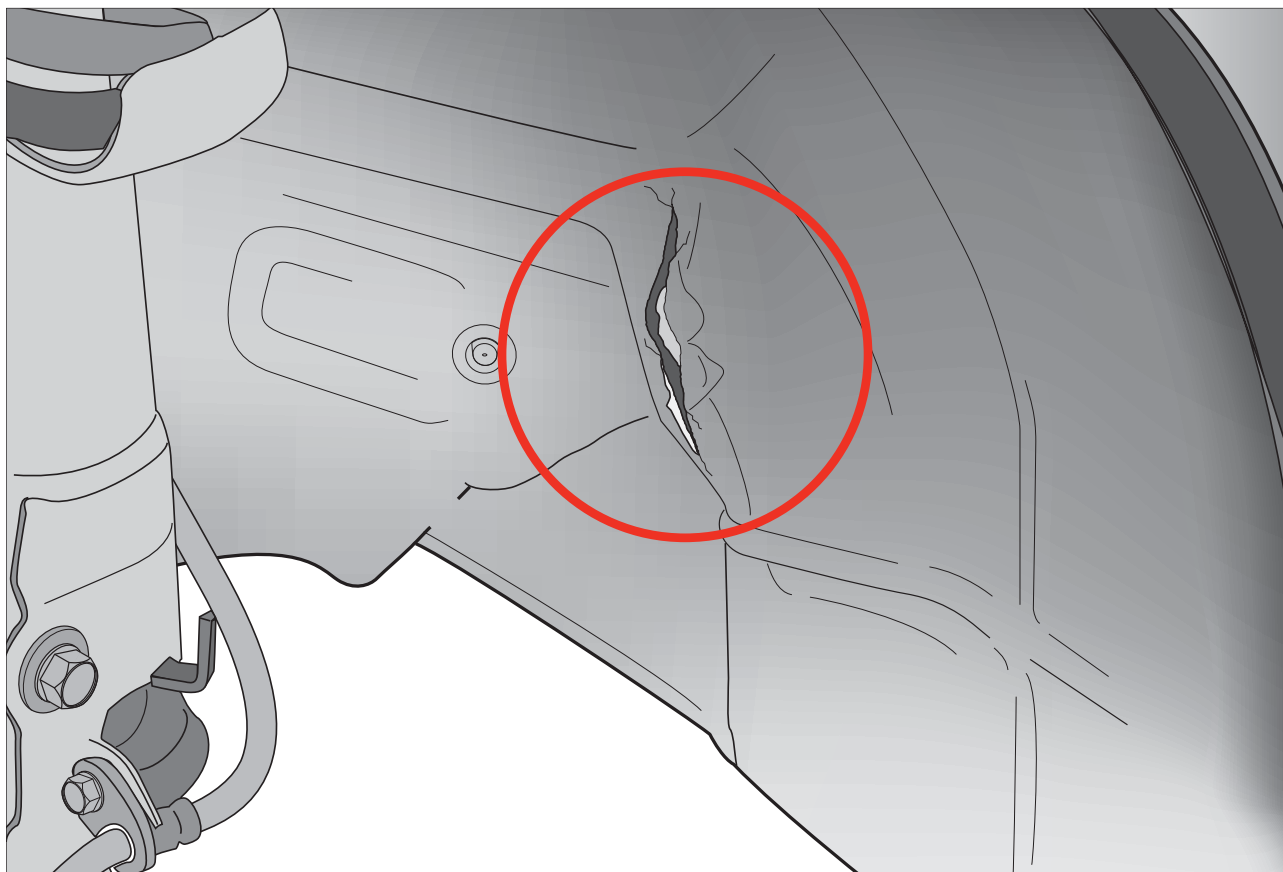
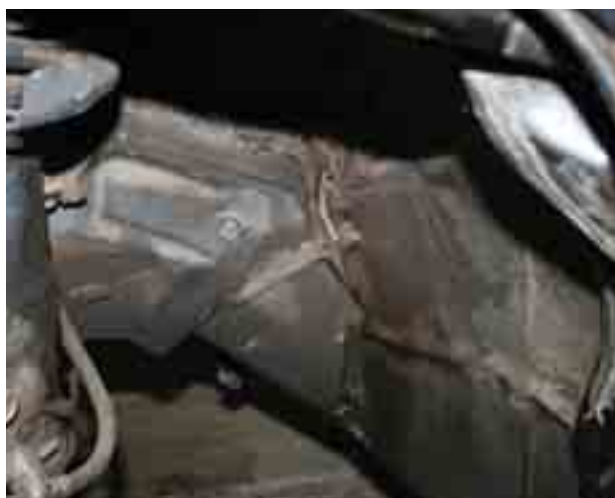
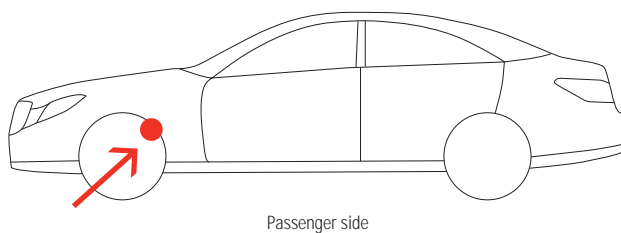
4.2 Firewall – cracked

View through the front left wheel-well of the firewall showing a crack in the firewall.

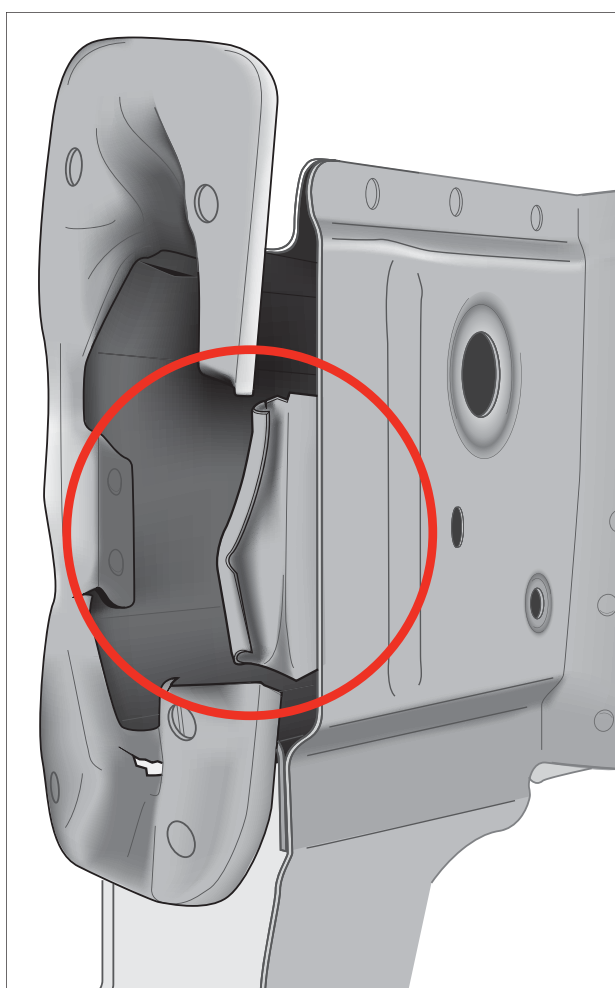
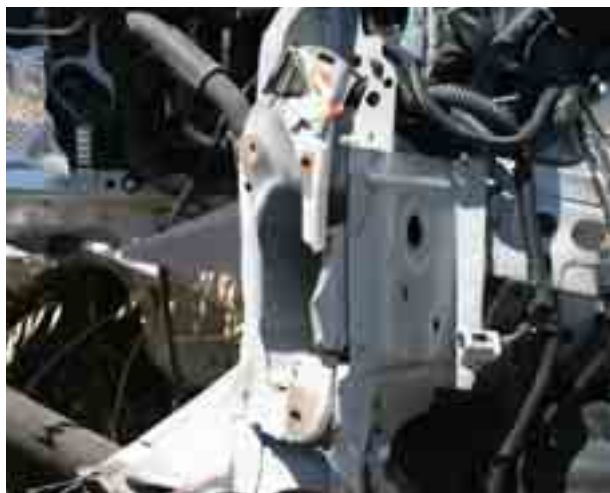
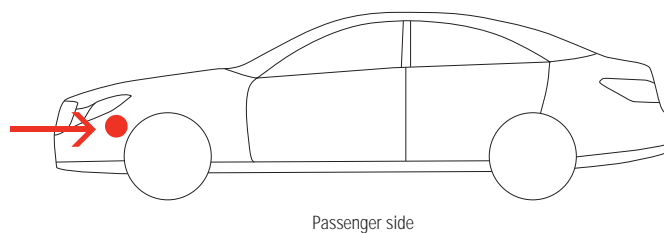
5.1 Chassis rail – fractured

View of longitudinal structural rail/chassis fractured due to impact.

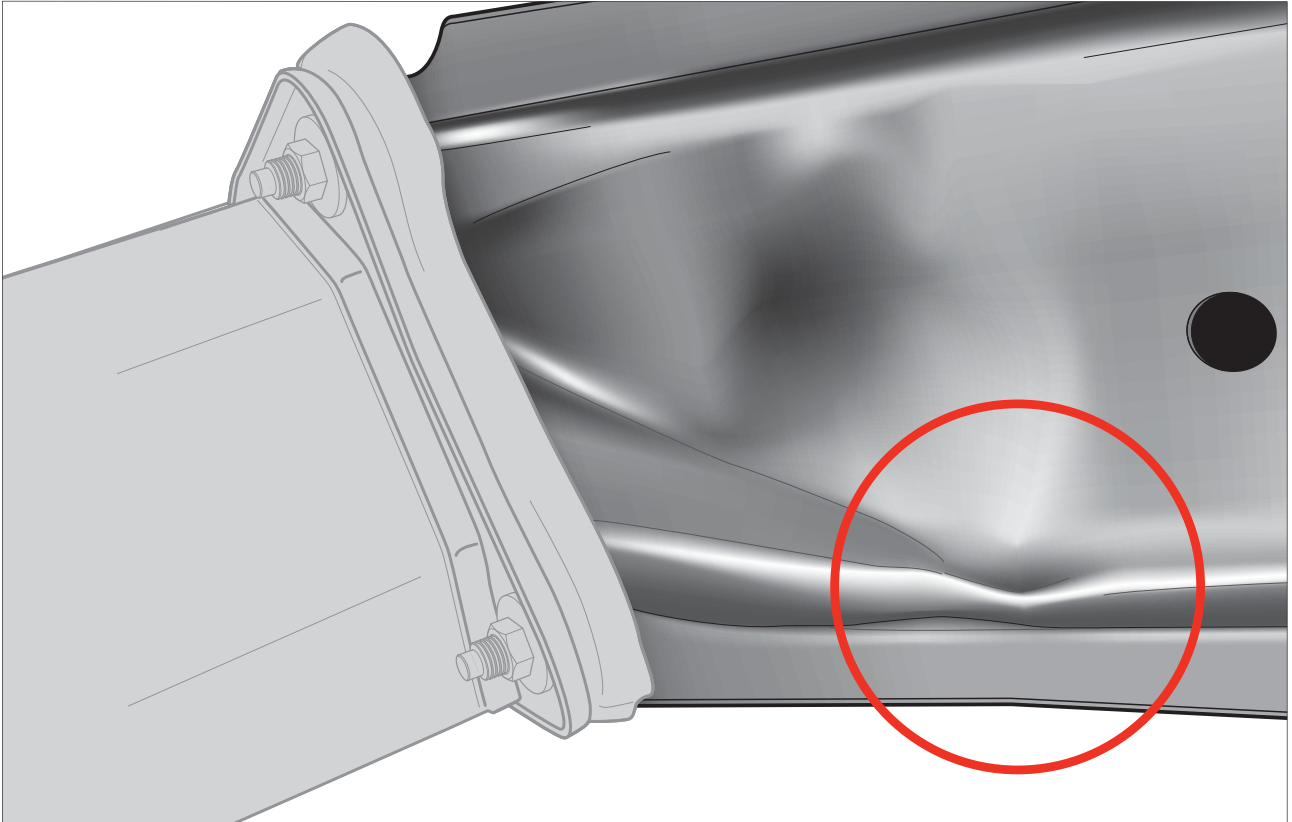
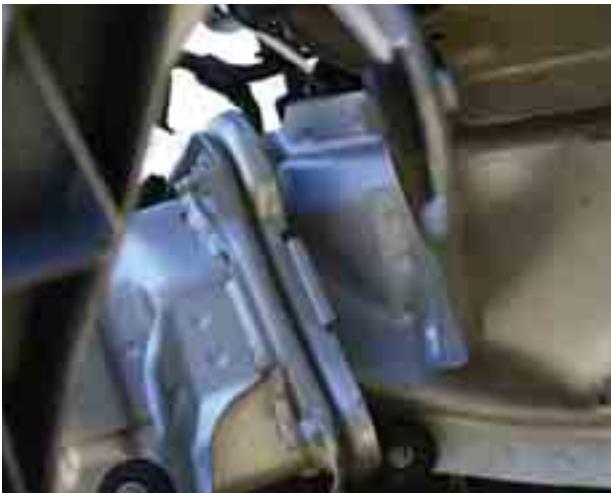
5.2 Chassis rail – buckled (side view)

View of a longitudinal structural/chassis rail which has buckled due to structural impact loading.

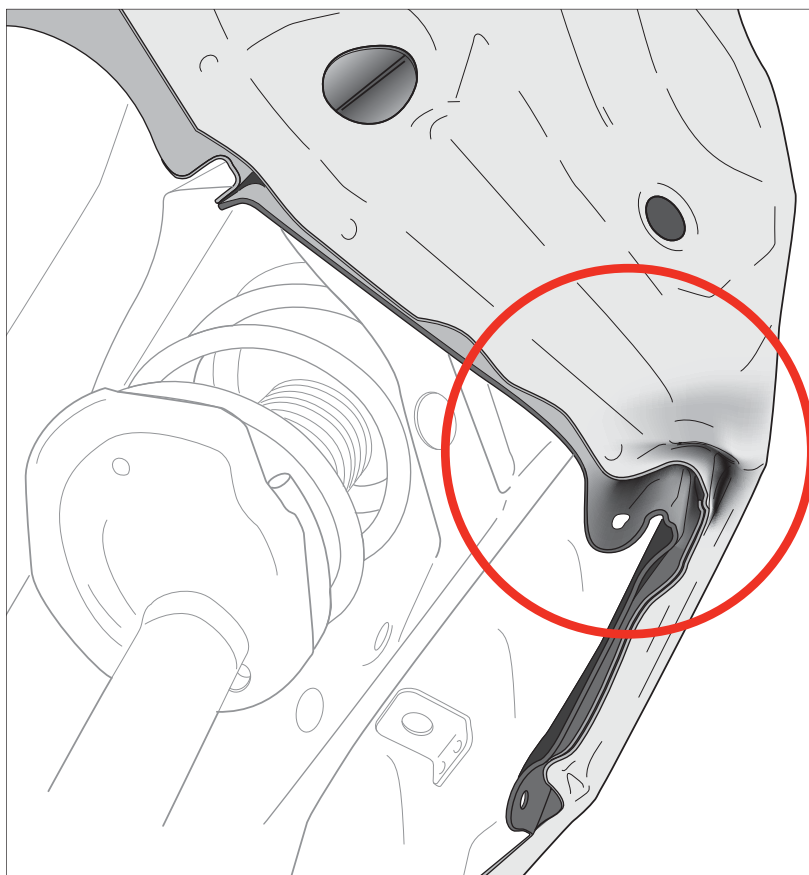
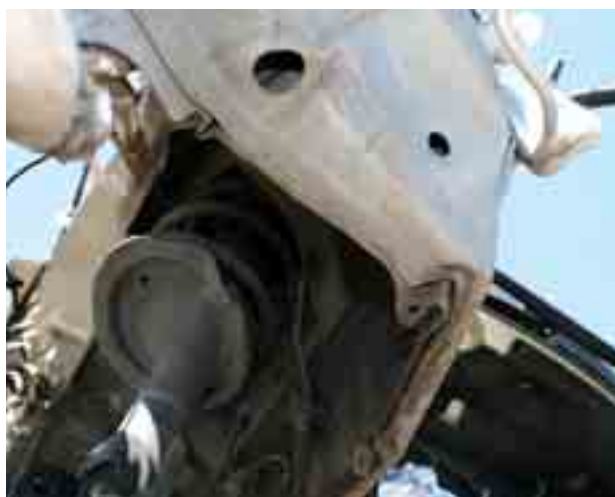
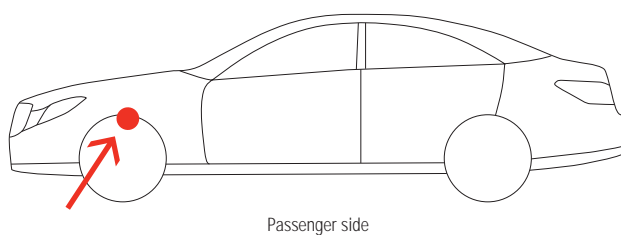
5.3 Chassis rail – folded

View of a longitudinal structural/chassis rail which has folded due to a side impact.

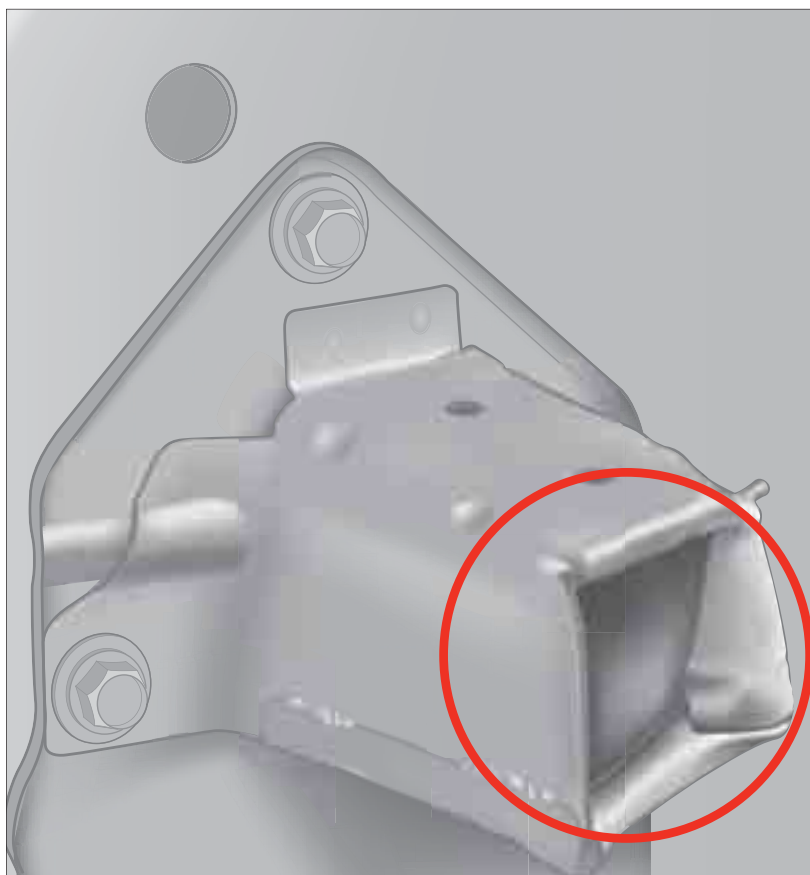
5.4 Deformable crush tube – damaged

This is an example of a deformable end plate that is designed to be removed and replaced. Such components are not to be registered as a damage count.

Note: A deformable member that is designed to be removed and replaced is not considered a fundamental structure of the vehicle if damaged and such components are not to be registered as a damage count.

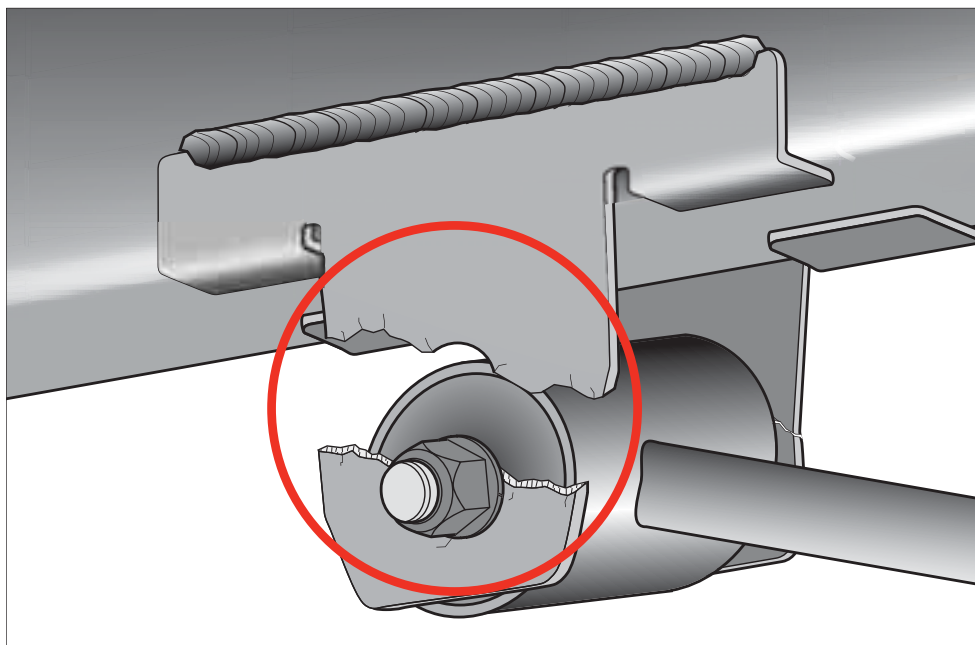
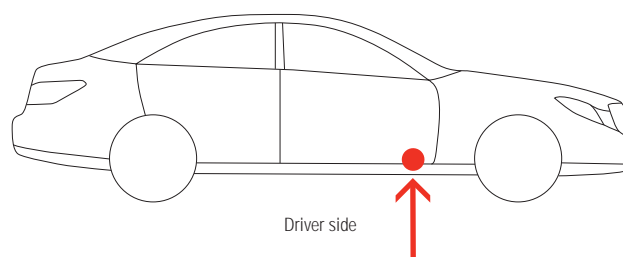
6.1 Suspension mount – fractured

View of a fractured suspension mount.

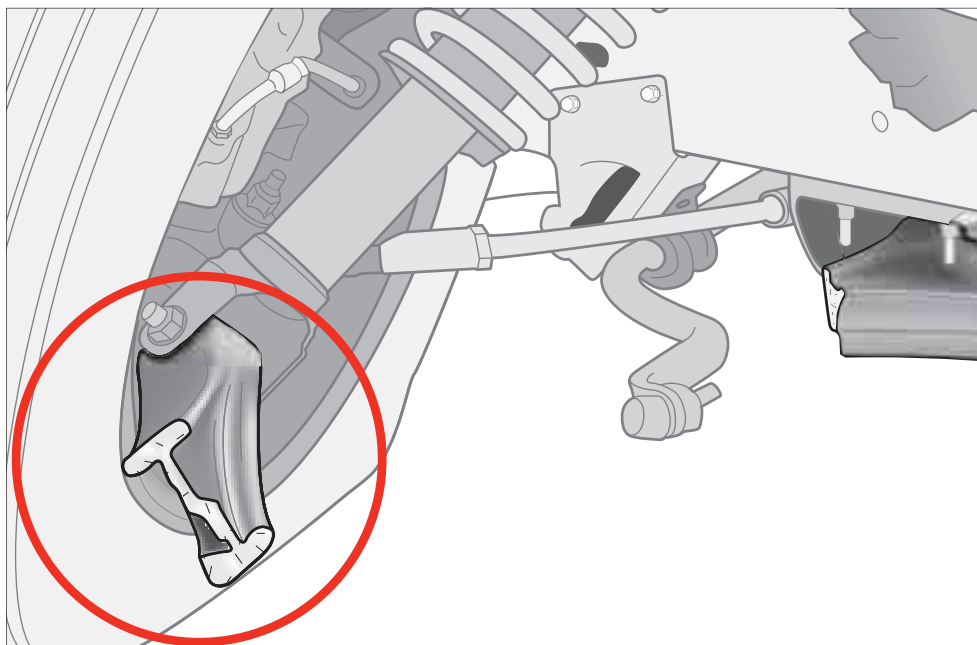
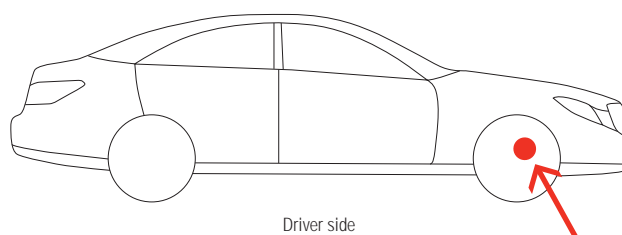
6.2 Suspension and linkages – damaged

This is an example of damaged suspension components that do not form part of the damage criteria because components such as suspension arms and linkages are designed to be removed and replaced.

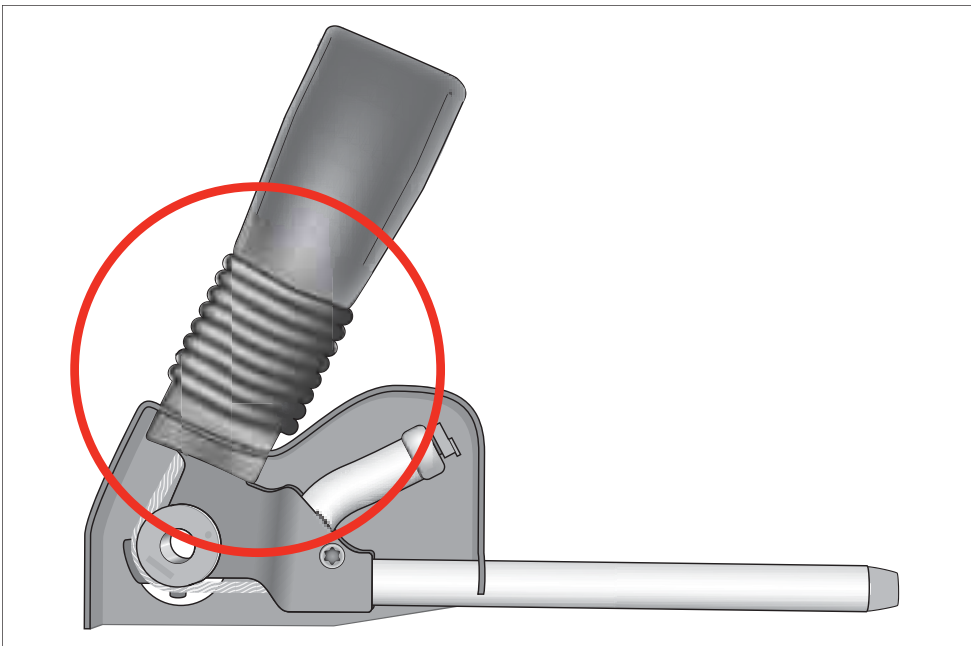
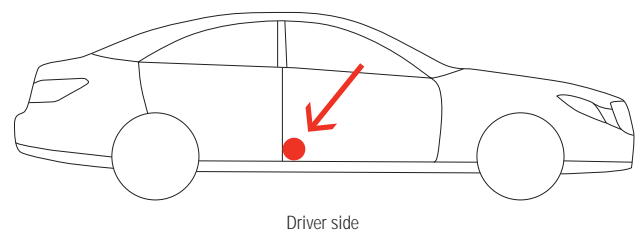
7.1 Pre-tensioner – active

View of a seat belt buckle showing a buckle with an active pre-tensioner.

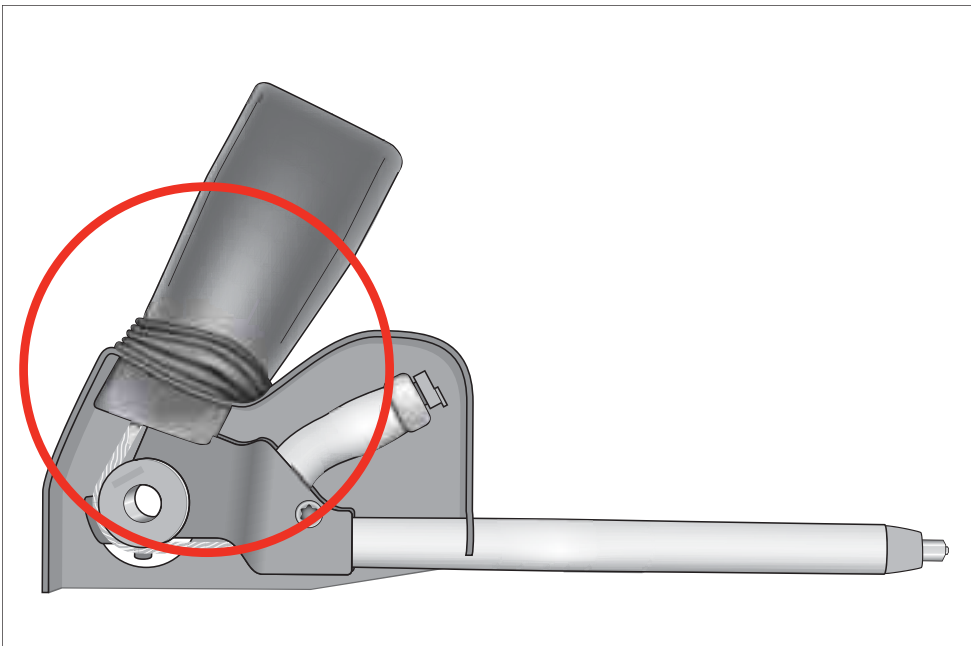
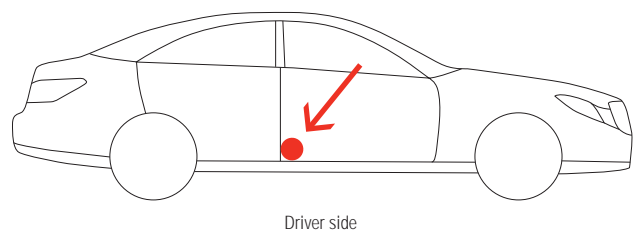
7.2 Pre-tensioner – fired

View of a seat belt buckle showing a buckle with a used pre-tensioner.

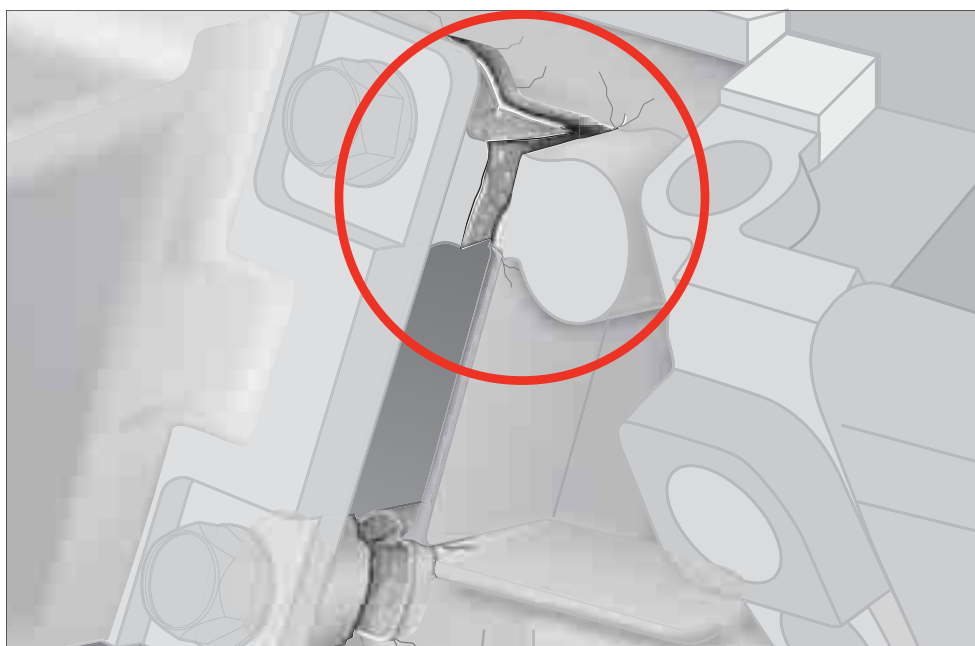
8.1 Engine mount – fractured

View of fractured engine and mount induced by a collision.

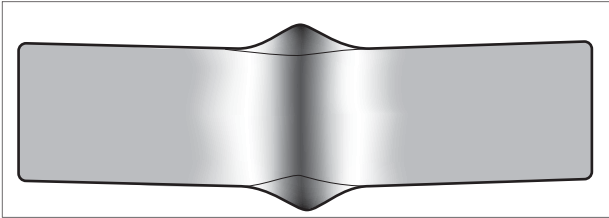
Buckle (top view)

The following illustrations depict the typical damage that would be consistent with the technical terms used throughout this guide.
